**UNITED STATES AIR FORCE**  
**AIRCRAFT ACCIDENT INVESTIGATION**  
**BOARD REPORT**

**T-38C, 65-0337, 11 FEBRUARY 2011**

**50TH FLYING TRAINING SQUADRON  
14TH FLYING TRAINING WING  
COLUMBUS AIR FORCE BASE, MISSISSIPPI**

**LOCATION: ELLINGTON FIELD, HOUSTON, TEXAS**

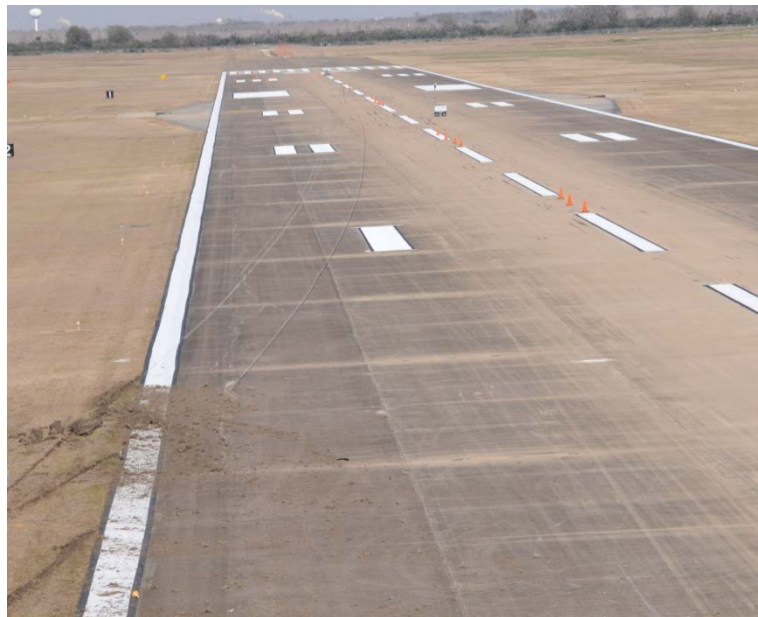
**m. Runway skid.** At impact, the right main landing gear wheel axle separated from the strut. The separated right wheel and axle departed the left side of the runway. (Tab J-3) The left main landing gear bent outboard. (Tab J-9) The stub of the right main landing gear then touched down on the runway. The right main stub supported the right side of the MA while dragging on the runway, creating sparks. (Tabs J-3, V-323)

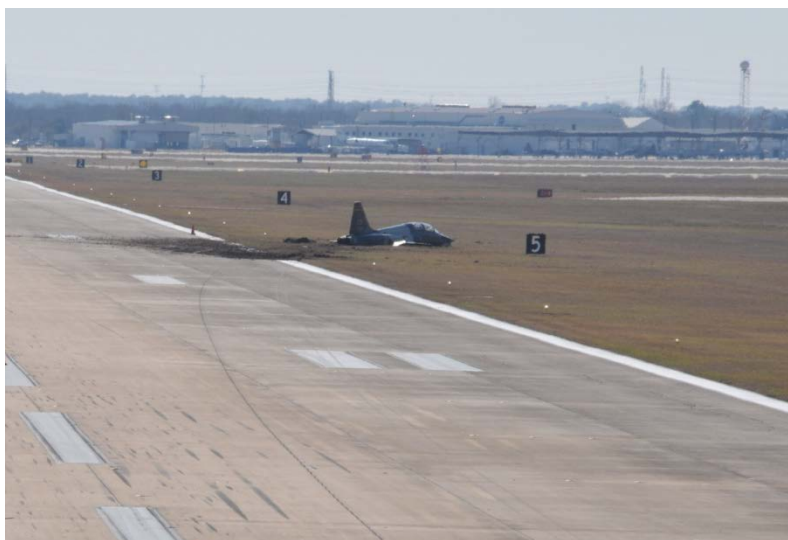
The MP recognized he would be unable to keep the aircraft on the runway. (Tab V-52 to V-53) He reported the last airspeed he saw prior to runway departure was 100 KCAS. (Tab V-53) His personally pre-determined minimum airspeed for a ground ejection was 70 KCAS. (Tab V-14) The MP reported seeing a hill off the right side of the runway as he was considering ejecting from the MA. Due to proximity of the perceived hill, combined with a perceived steep right bank and fear that he would hit the hill upon ejection, the MP elected not to eject from the MA. (Tab V-15)

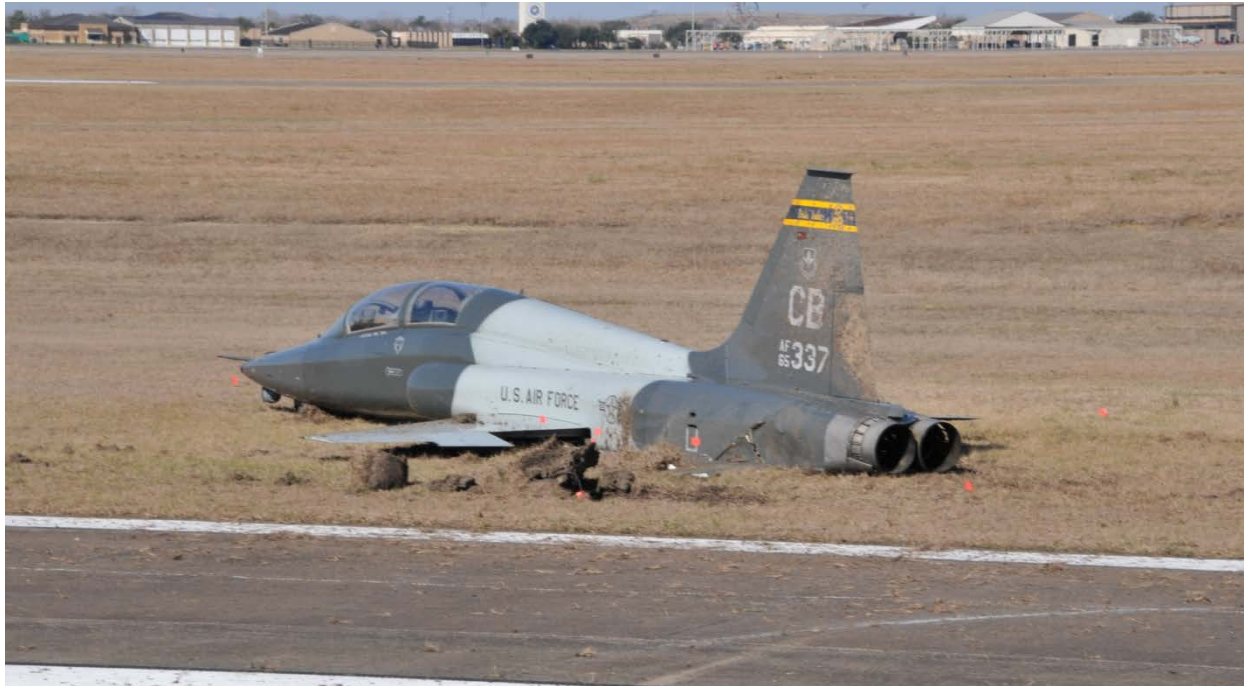
**n. Runway Departure.** At 2017:25, the MA’s right main landing gear stub departed the runway surface 2,285 feet from the point of impact. (Tabs L-42, DD-74) The MA was traveling at 89 KCAS or 81 knots ground speed. The MA began yawing further to the right. (Tabs L-42, DD-45) The MA’s nose wheel and right main landing gear stub independently impacted a concrete footing for a runway light. The nose landing gear sheared at the strut. (Tab J-3) The MA abruptly yawed to the right, reaching a maximum heading of 333°. The MA initially banked further to the right, reaching a maximum right bank of 13.73°. (Tab L-42) The left main landing gear then collapsed. (Tab J-3) This resulted in a rapid roll to the left. The maximum left bank was 19.28°. (Tab L-42) The left horizontal stabilizer dug into the dirt, resulting in an abrupt

yaw back to the left and a rapid deceleration. (Tabs J-3, L-22, L-42) The MA came to rest at 2017:28, just 3 seconds after departing the runway, with a heading of 261°. (Tab L-22, L-42) The tail of the aircraft was 2,546 feet from the impact point and 96 feet to the right of the runway centerline (21 feet right of the edge of the runway). (Tabs K-24, DD-74)
