UNITED STATES AIR FORCE
AIRCRAFT ACCIDENT INVESTIGATION
BOARD REPORT

F-15E STRIKE EAGLE, T/N 91-000304

ACCIDENT LOCATION: NEAR BENGHAZI, LIBYA

DATE OF ACCIDENT: 21 MARCH 2011

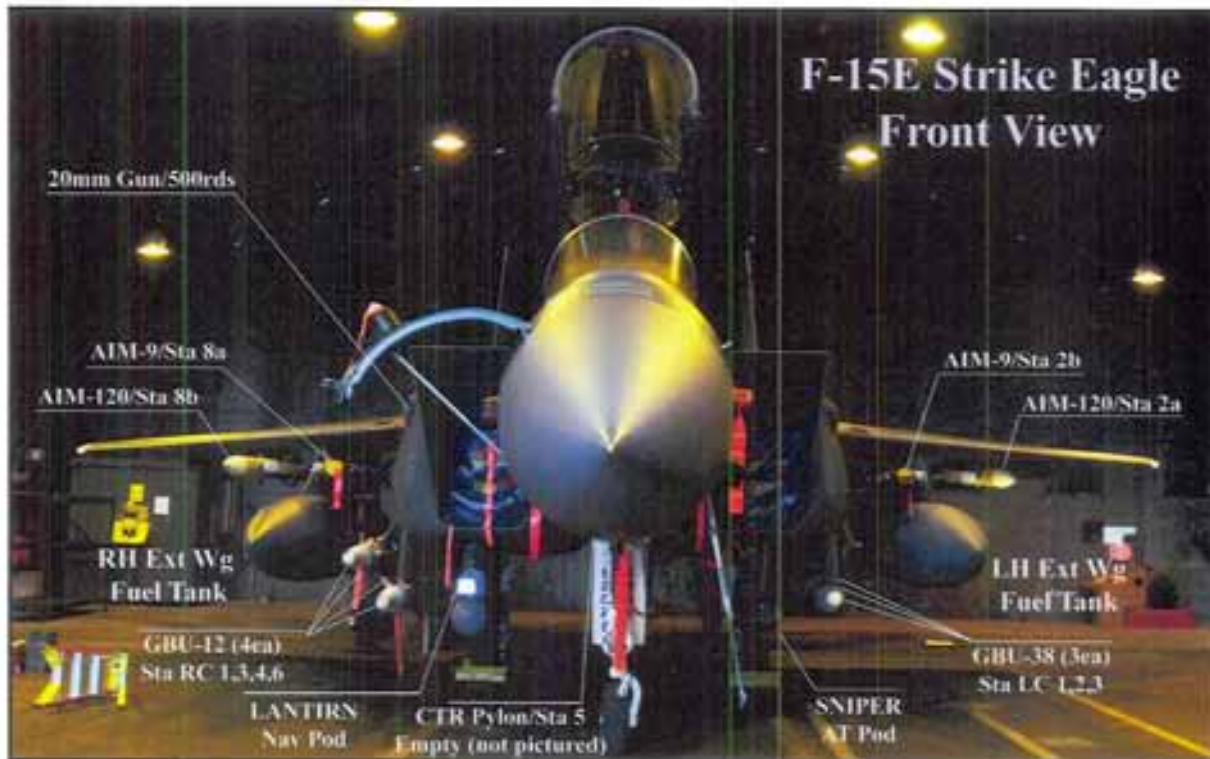
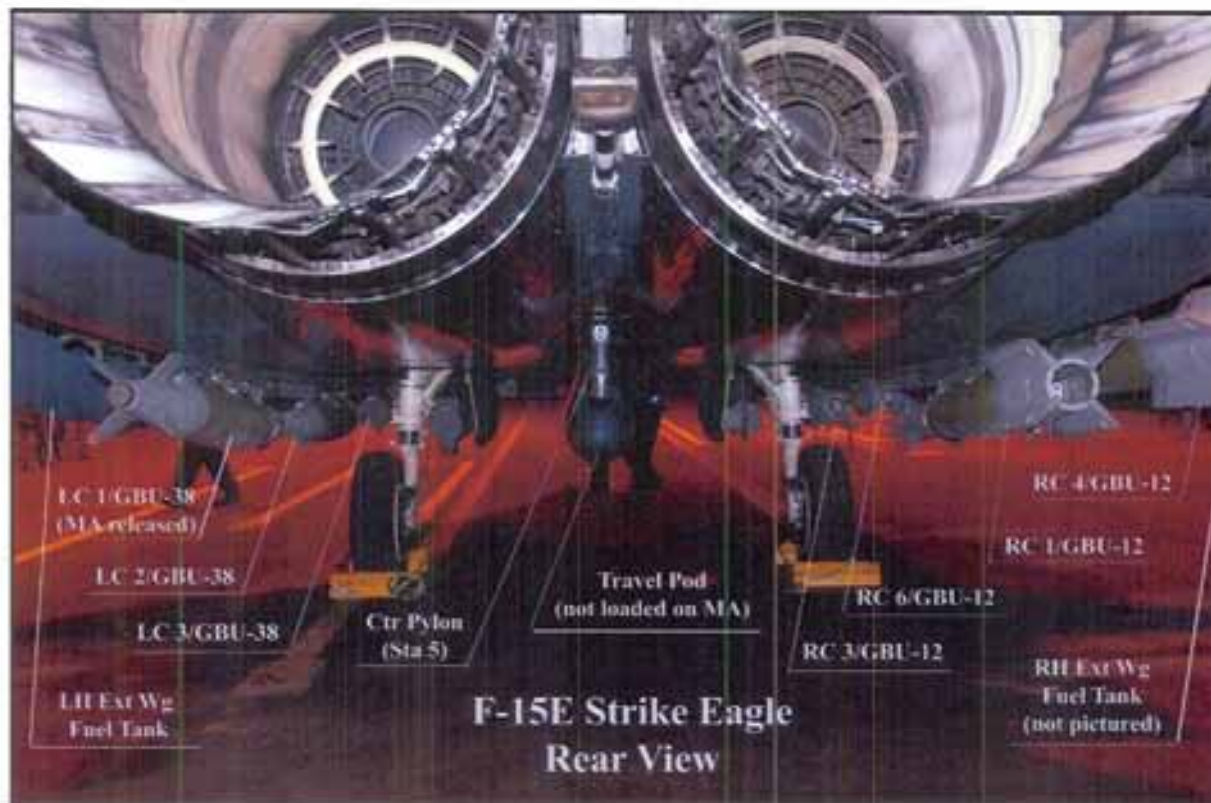
In order to execute mission objectives, the MF was configured with two AIM-120s (outboard wing stations 2a, 8b), two AIM-9s (inboard wing stations 2b, 8a), two 610 gallon external fuel tanks (wing stations 2, 8), two 750 gallon Conformal Fuel Tanks (CFTs), Sniper Advanced Targeting Pod, LANTIRN Navigation Pod, three GBU-38s (Left Conformal stations 1/2/3), four GBU-12s (Right Conformal stations 1/3/4/6), 500 20mm rounds of ammunition, and centerline pylon not loaded with stores. The aircraft is inherently right wing heavy by 1,850 foot pounds (ft-lbs) due to the gun and its support equipment; with the added stores, the MA had a take-off lateral imbalance of 8,168 ft-lbs (Tabs V-1.7, V-1.14, V-2.6, V-4.6, AA-13 to AA-16).

The photographs below depict a front and back view of the F-15E's munitions configuration. Photographs were provided by the Air Force Public Affairs Office at RAF Lakenheath, UK. Labels and descriptions were added by the AIB based on witness and documentary evidence.

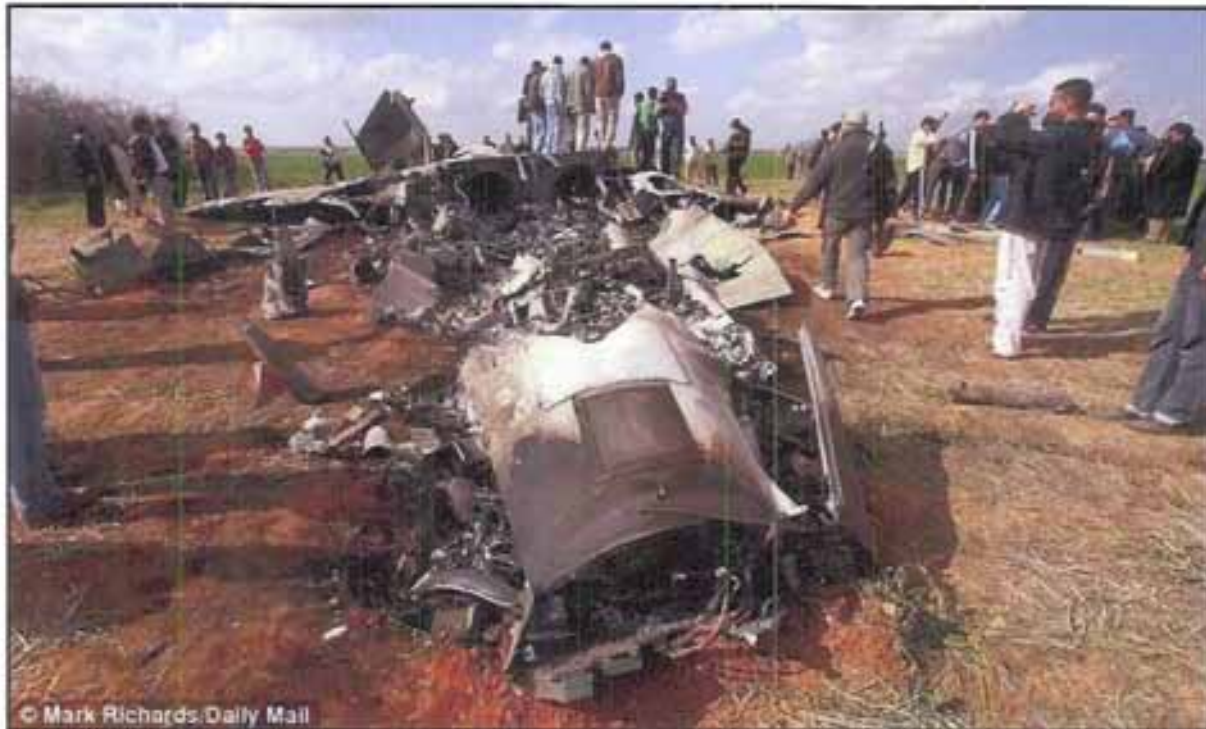
Front View of Mishap Aircraft's Nose Section

The MA impacted the ground at approximately 2129Z in an unpopulated area near Benghazi, Libya and was destroyed. Photographs from the impact site indicate the MA struck the ground flat with near zero forward velocity and significant left rotation. This damage to the MA is consistent with a left flat spin. There were no known civilian casualties or additional damage at impact (Tabs M-3, M-4, N-4, P-5, and S-4 to S-18).

The photograph shows the MA impacted the ground in a spin. This is apparent from the fact that the length of the MA is not significantly compressed, the aircraft nose is compressed flat on the ground, and the ground around the nose section is not cratered or significantly scarred.

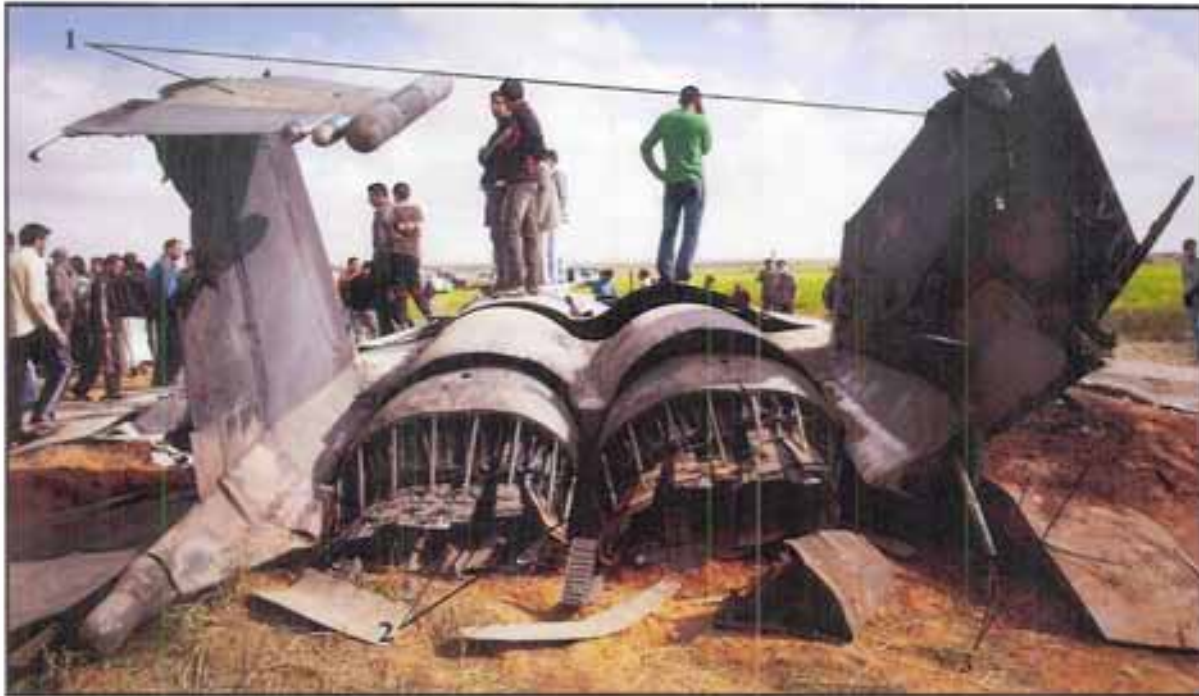
Back View of Mishap Aircraft on Impact

The photograph shows the MA was rotating left upon impact. The flat left spin rotation is evident from (1) the tops of the vertical tails which are mainly intact; (2) the compressed engine nozzles; and (3) the soil covering the right horizontal stab.

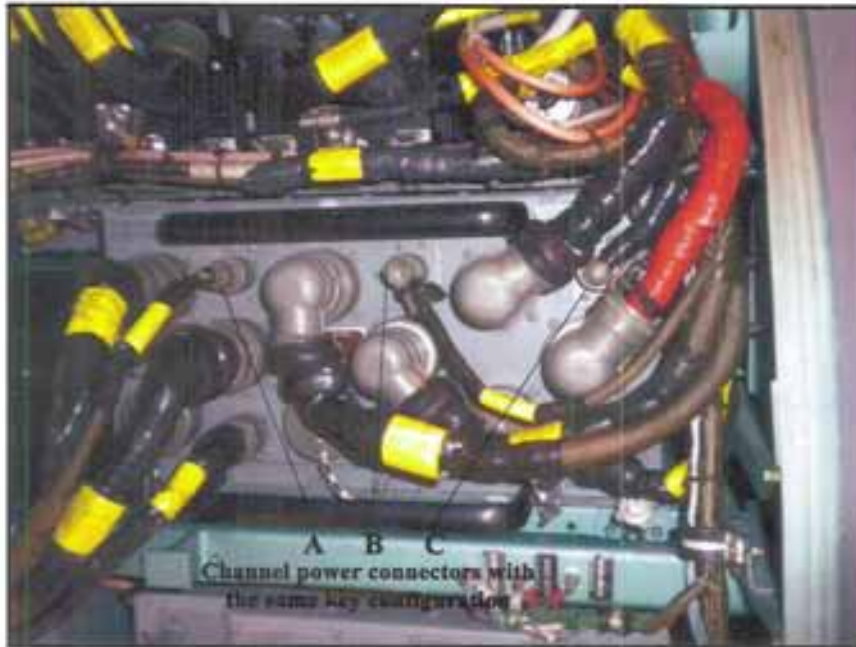
FCC Channel Power Connectors

The photo above shows properly configured FCC connections. Of note, the A, B, and C channel power connectors all have the same connector/receptacle key configuration. The B and C connectors are often mistakenly reversed during installation due to the matching connector/receptacle key configuration and the close proximity to each other.
