UNITED STATES AIR FORCE
AIRCRAFT ACCIDENT INVESTIGATION
BOARD REPORT

F-15C, TAIL NUMBER 86-0157
131ST FIGHTER SQUADRON
104TH FIGHTER WING
BARNES AIR NATIONAL GUARD BASE, MASSACHUSETTS

LOCATION:
GEORGE WASHINGTON NATIONAL FOREST, VIRGINIA

DATE OF ACCIDENT: 27 AUGUST 2014

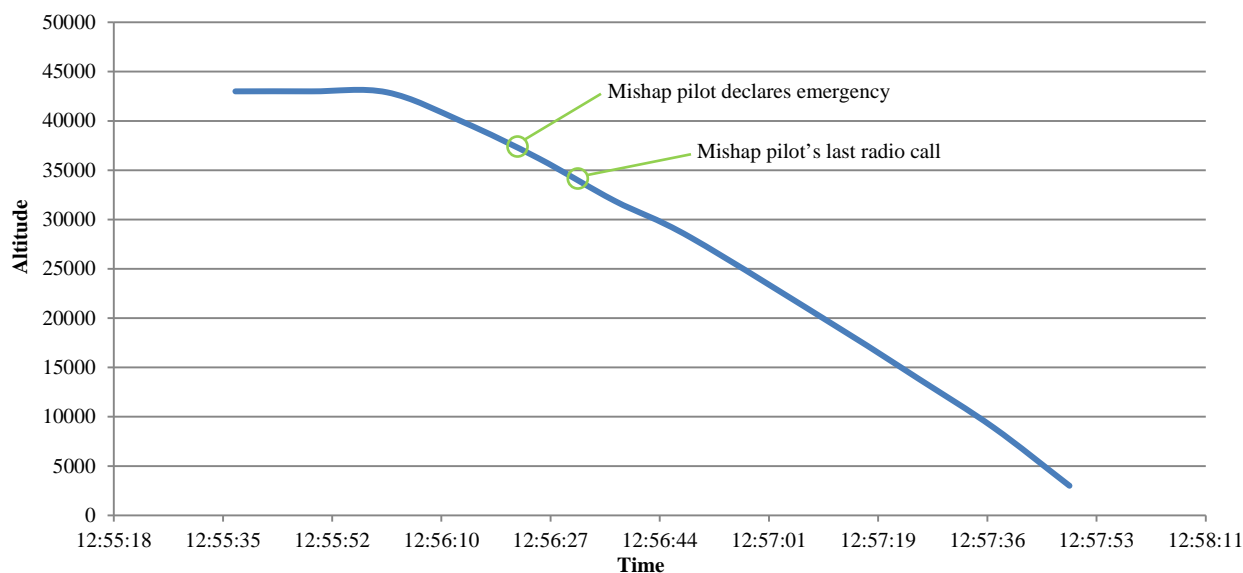
At 0855:58, MP began a descent (Tab M-2.12). Radar data showed the MA initially descending at a rate of approximately 12,000 feet per minute (Tabs M-2.12 to M-2.13 and EE-3). At 0856:11L, Washington Air Route Traffic Control Center (Washington Center) requested MP to make a routine radio frequency change (Tab N-3.12). At 0856:24L, while passing Flight Level 380 (approximately 38,000 feet MSL), MP responded, “HAWK 11 declaring emergency” (Tabs M-2.12 and N-3.12). Washington Center acknowledged the emergency and requested MP’s status (Tab N-3.12). At 0856:31L, MP responded, “Affirm. Standby.” while passing Flight Level 360 (approximately 36,000 feet MSL) (Tabs M-2.12 and N-3.12). This was the last communication received from MP despite numerous attempts by Washington Center to make contact for additional information (Tab N-3.12 to N-3.13).

After the initial descent at 12,000 feet per minute, the MA continued to accelerate and descend (Tab M-2.12 to M-2.13). Prior to impact, the MA reached supersonic speed, indicating that no catastrophic structural failure occurred before impact (Tab J-6). Radar data showed no evidence that MP maneuvered to recover the MA between the final call to Washington Center and impact (Tabs M-2.12 to M-2.13 and GG-50). At Flight Level 360, MP was at a sufficient altitude to recover or eject from the aircraft (Tabs H-2 to H-3, V-20.4 to V-20.5, and EE-4).

Figure 2: Altitude of Mishap Aircraft Over Time after Leaving Flight Level 430 (Tabs M-2.12 to M-2.13, N-3.12 to N-3.13, and GG-62)

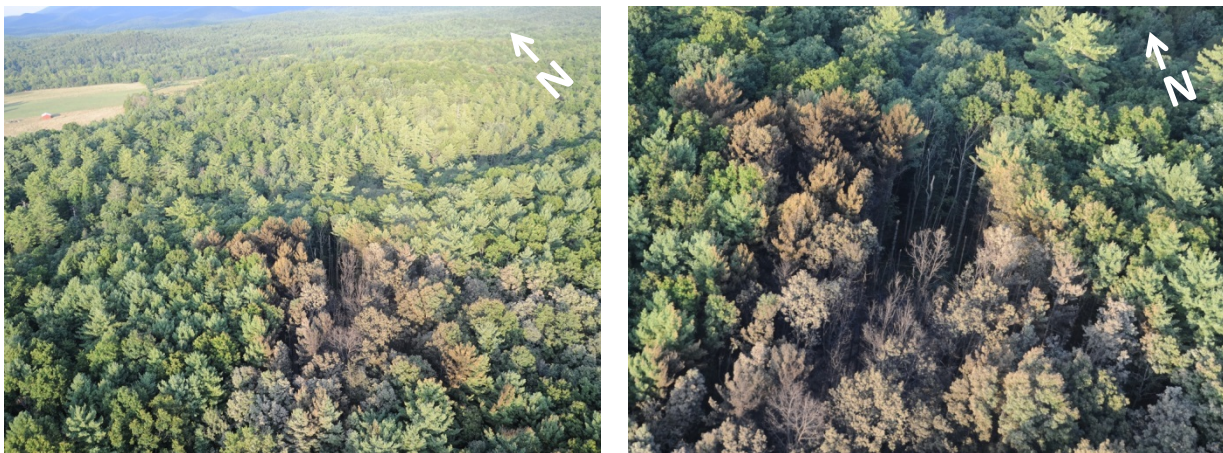
The MA impacted the ground at approximately 0858L in a densely forested area of the George Washington National Forest (Tabs M-2.13, N-3.15, and Z-3). Pieces from all the main sections of the MA were found at the crash site, indicating that there was no catastrophic structural failure prior to impact (Tab J-6). The MA created a large crater (approximately 15 to 20 feet deep) at the point of impact (Tab J-2). At the time of the impact, the MA was inverted between 60 to 70 degrees nose low (i.e., upside down and pointed sharply toward the ground) and traveling at an airspeed greater than 0.83 Mach (Tab J-2 and J-25). The MA's engines were operating normally in a mid-range power setting—the standard power setting at cruising altitude for a cross-country flight—at the time of impact (Tabs J-78.10 and V-22.5).

Figure 3: Aerial Images of Crash Site Taken at 1851L on 27 August 2014 (Tab Z-3)

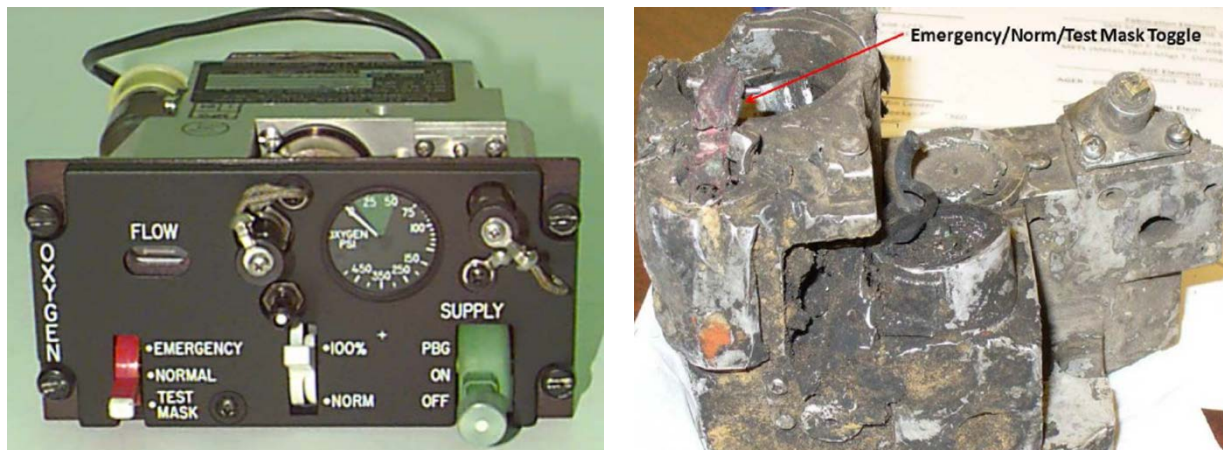
GOX from the heat exchanger is supplied to a cockpit-mounted oxygen regulator, manufactured by Cobham plc (Cobham), for delivery of breathing gas to the pilot (Tabs J-8 and FF-3). On 22 August 2014, the MA's cockpit-mounted oxygen regulator was inspected (Tabs V-14.3 to V-14.5 and FF-3). No defects or non-functioning conditions were noted (Tabs V-14.3 to V-14.5 and FF-3). The MA's oxygen regulator was recovered from the crash site and provided to Cobham for analysis (Tabs J-8 and GG-4). However, due to the severity of damage sustained during impact, Cobham's analysis was inconclusive concerning the status of the regulator prior to impact (Tab GG-3 and GG-37).

Figure 5: Image of Intact Oxygen Regulator and Image of Damaged Oxygen Regulator from the Mishap Aircraft (Tab J-7 and J-9)
