UNITED STATES AIR FORCE
AIRCRAFT ACCIDENT INVESTIGATION
BOARD REPORT

F-15D, T/N 86-0182

**493D FIGHTER SQUADRON
48TH FIGHTER WING
RAF LAKENHEATH, UNITED KINGDOM**

DATE OF ACCIDENT: 8 OCTOBER 2014

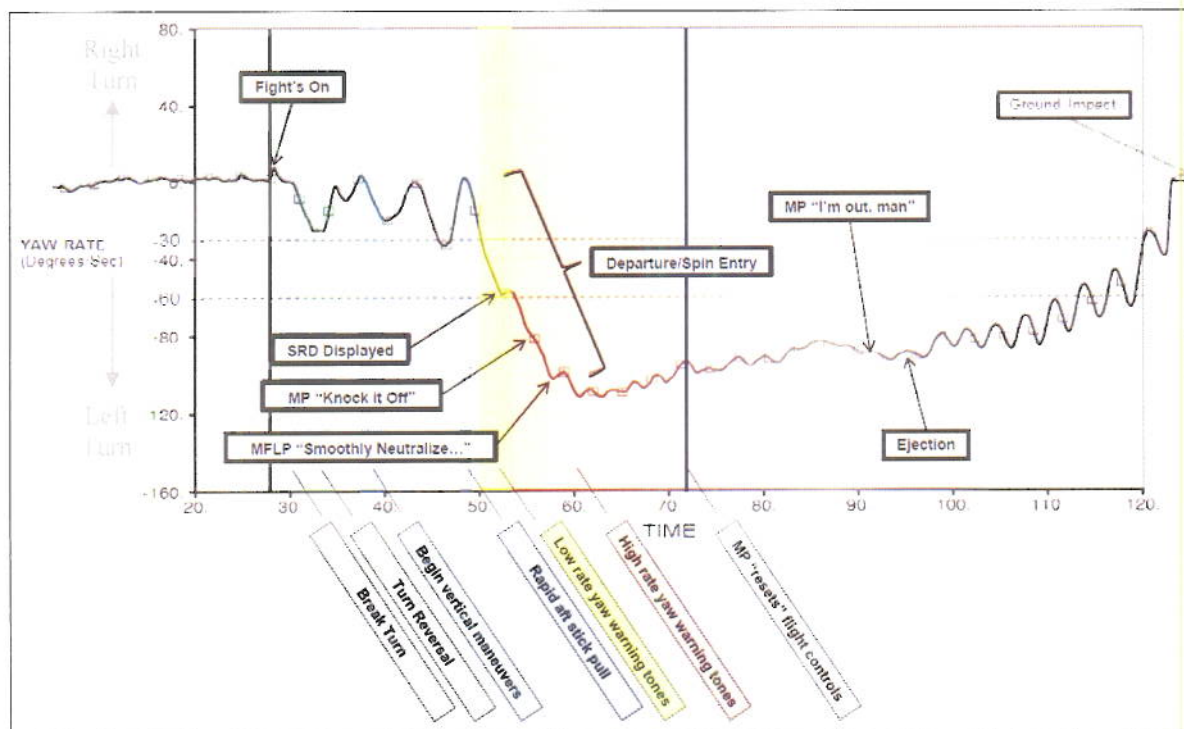
Figure 2: MA Yaw Rate During Final Engagement

Ten seconds after the initial nose slice and passing 12,200 feet MSL, the MA's yaw rate peaked at 111° per second (See Figure 2; Tab J-18, GG-1.2). At this point, the MA was established in a flat erect spin, as defined in the F-15 Flight Manual (See Figure 2 on the next page for a depiction of yaw rate throughout the mishap sequence; Tab V-1.6, BB-2.16). Even with full

anti-spin flight controls, the MA spin rate slowed at only 1° per second² (Tab J-24). At this rate of recovery, it would take between 10,000 and 15,000 feet for the MA to recover (Tab J-27).

The MP testified that he perceived the yaw rate decay (i.e., the degree to which the spin was slowing) as indicating imminent recovery, however, the MA never actually recovered as quickly as he expected (Tab V-1.7). At approximately 10,000 feet MSL, the MP momentarily released the control stick to validate the longitudinally neutral position before reapplying full left (anti-spin) aileron (Tab V-1.7, V-1.25). This stick movement momentarily neutralized the ailerons and took out anti-spin flight controls. As a result, the MA experienced a slight increase in yaw rate and an overall slight reduction in the yaw's rate of decay through the remainder of the spin (Tab J-18).

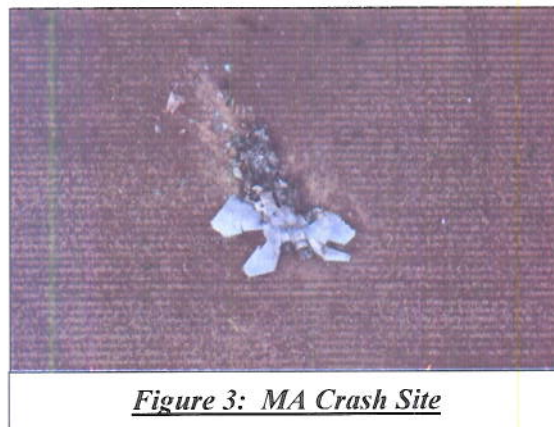
The MA impacted the ground in a field at 15:28:38L at N52-45.4 E000-06.9, approximately three miles southeast of Spalding, Lincolnshire, UK (See Figure 3; Tab S-12, GG-2). The landing gear, flaps, and speedbrake were all retracted at impact (Tab J-5, J-10, J-13). MA parameters at impact were 105 KCAS, 50° nose-low, in 45° left bank, and on a northwest heading (Tab HH-1). There were no civilian injuries or fatalities (Tab FF-5). Private property damage included fire and impact damage to a local farmer's field (Tab P-2, FF-5).

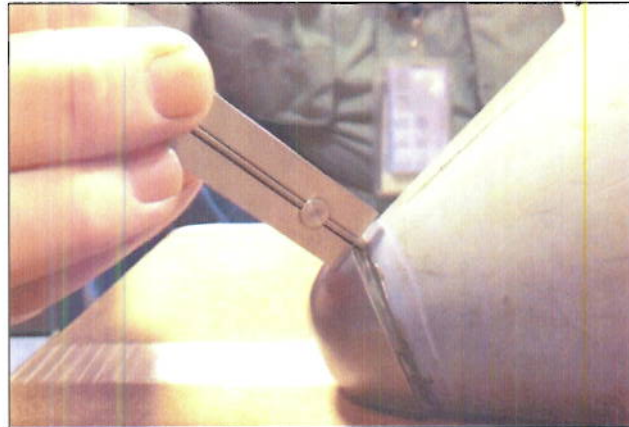
Figure 4: MA Radome

Nose Cap Condition: Mishap investigators discovered the first 8-10 inches of the aircraft radome in usable condition for analysis (Tab J-20). Figure 4 shows a close up of the tip of the MA's radome, which is protected by a metallic covering called a nose cap. F-15 SPO post-crash analysis assessed that there was a large gap between the radome body and nose cap, and that an excessive amount of sealant extruded from behind the nose cap (See Figure 4; Tab J-20, J-51). The sealant extruded up to 3/16 of an inch aft of the nose cap and created an uneven aerodynamic surface.

Given the large amount of sealant required to seal the nose cap in place, some of that sealant extruded from underneath the nose cap (Tab J-20, J-51). Normally, this extruded sealant, also referred to as “squeeze out,” is cleaned from the nose cap assembly (Tab V-2.7 to V-2.8, V-6.6, V-7.7). Post-mishap analysis, however, shows that efforts to clean or smooth this “squeeze out,” were insufficient and left a larger than normal amount of extruded sealant beyond the aft edge of the nose cap (See Figure 4; Tab J-20, J-51).

Analysis of the first 8-10 inches of MA radome, discovered intact at the crash site, revealed there was a large gap between the radome body and the nose cap. At an undetermined time prior to the mishap, the nose plug of the radome became displaced from the radome's composite shell by 3/32 of an inch. The last recorded radome maintenance was accomplished on 22 January 2014, at which time the maintenance technician likely installed the nose cap over the radome and nose plug in this condition. As a result, a larger than normal amount of sealant was required to properly seal the nose cap in place. Some of this sealant extruded from underneath the nose cap, was insufficiently cleaned from the radome surface, and created an uneven aerodynamic surface.

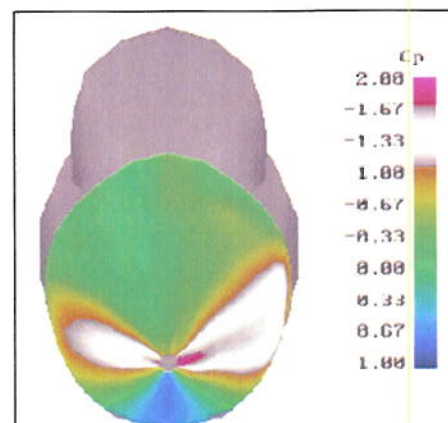
Figure 5: Pressure differential due to asymmetric vortex shedding

The yaw forces generated by radome imperfections are due to "asymmetric vortex shedding" (Tab J-19). Figure 5, adapted from a 2000 Atmospheric Flight Mechanics Conference paper, shows the asymmetric pressure differential experienced in these conditions (C_p stands for coefficient of pressure). The white area depicts negative pressure, or suction, naturally present due to airflows that start at the radome tip and radiate along the fuselage. (Tab JJ-1.5, JJ-1.11). When these airflows separate from the nose, a region of positive pressure develops (depicted by the reduced region of white on the left side of the picture). This zone, starting at the tip of the radome, can extend up to 11 feet along the side of the aircraft fuselage. This "zone of pressure differential" not only spreads along the side of the fuselage, but also acts like a 27-foot long lever from the aircraft's center of gravity (also referred to as a moment arm). As a result, this pressure differential can create extreme yaw forces

(Tab BB-6.4). While asymmetric vortex shedding will always happen at extreme AOA levels, radome imperfections lower the AOA at which this can occur to as low as 50 CPU (Tab BB-6.4).

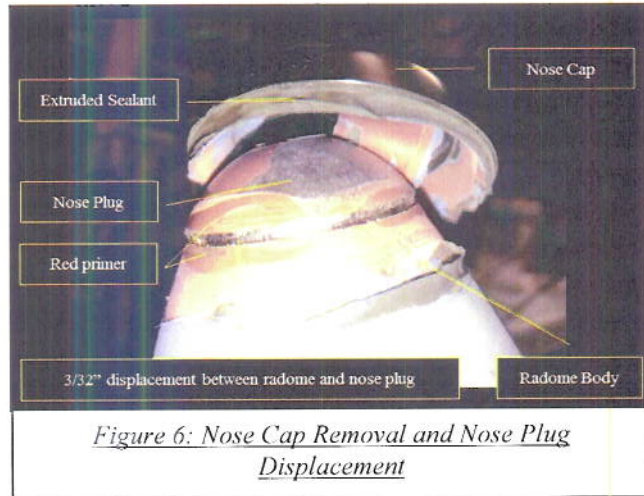
Radome Configuration: The radome's nose assembly is comprised of the composite radome shell, a metallic nose plug that is seated into the tip of the radome (like a cork is seated in a bottle), and a metallic nose cap that fits over the entire assembly. The nose cap is secured to the nose plug and radome with sealant and a small screw installed at the apex of the nose (See Figure 6; Tab V-2.7, V-6.4, V-7.4). The F-15 SPO's breakdown analysis discovered that the nose plug was displaced by 3/32 of an inch from its proper seating in the radome. (See Figure 6; Tab J-55). The F-15 SPO concluded that at

an unknown time, during nose cap removal, "the application of heat and/or blunt force necessary to remove the [nose cap] also caused the [nose plug] to pull...away from the [radome body]" (Tab J-55). This nose plug displacement can be seen in Figure 6 where there is silver metal showing between the red primer painted on both the radome body and nose plug. Normally, a nose cap should fit snugly over the nose plug-radome assembly; however, efforts to install the nose cap over the nose plug/radome assembly with this displacement created a large gap between the nose cap and radome (See Figure 7).
