**UNITED STATES AIR FORCE**  
**AIRCRAFT ACCIDENT INVESTIGATION**  
**BOARD REPORT**

**F-15C, T/N 84-0008**

**44TH FIGHTER SQUADRON**  
**18TH WING**  
**KADENA AIR BASE, JAPAN**

**DATE OF ACCIDENT: 11 JUNE 2018**

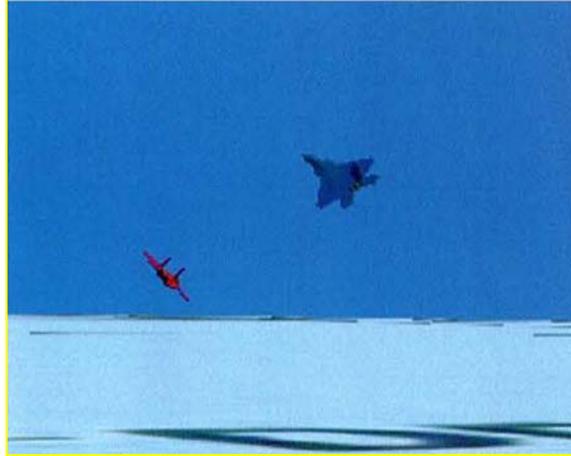
**Figure 4.2, 06:16:29L (Tab Z-4)**

The MP recalled an airspeed of approximately 220 to 230 KIAS and 5,900 feet MSL during this maneuver (Tab V-2.3). The MP used right rudder and pro right yaw differential throttles; left engine in maximum afterburner and right engine in minimum afterburner to reverse the turn direction to the right (Tab V-2.3 and V-2.9). The MP assessed the MW would remain offensive and not significantly overshoot and attempted to continue the defensive turn to the right by slicing out of the MW’s plane of motion with approximately 200 KIAS and 60 to 90 degrees right angle of bank (Tabs V-2.3, V-2.7, V-2.8 and BB-237). In response, the MW executed a reposition by pulling the nose of MW’s aircraft away from the MA into a climb above and slightly aft of the MA (See Figure 4.2) (Tab R-3). KITS data confirmed this portion of the MP and MW’s accounts, showing the MP initially turned with 60 to 80 degrees of right bank (See Figure 4.2), then to 110 degrees right bank, pulling for five seconds across (parallel to) the horizon, with 5 to 10 degrees of nose low pitch and 180 KIAS (Tab J1-8).

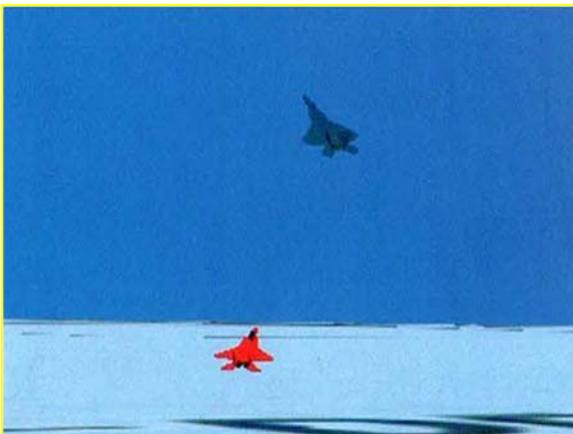
**Figure 4.3, 06:16:32L (Tab Z-4)**

The MP recalled continuing a right, descending turn with 900 feet of altitude remaining above the flight floor of 5,000 feet MSL, with right rudder, differential throttles and the stick three quarters aft and centered (Tab V-2.7 to Tab V-2.9). However, KITS data, supported by MW testimony, revealed that the MA's lift vector had shifted from tracking across the horizon (60-90 degrees of bank) to nearly straight up in the vertical, eventually settling at 20 degrees of right bank angle (See Figure 4.3) (Tabs J1-8 and R-3). KITS data showed the MA pitched up initially to 40 degrees nose high, and after a pause, to 65 degrees nose high (Tab J1-8).

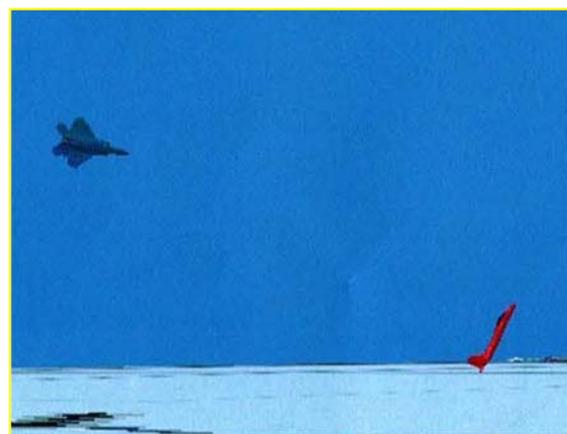
**Figure 4.4, 06:16:45L (Tab Z-4)**

The MA's airspeed decreased to 145 KIAS, then to 105 KIAS while altitude increased from approximately 5400 feet MSL to 6300 feet MSL and G forces decreased from +1.2 to +0.5 Gs with a maximum angle-of-attack (AOA) of 39 degrees (See Figure 4.4) (Tab J1-8 to J1-9 and J1-11). AOA is the angle between an aircraft wing's mean aerodynamic chord and the relative wind (Tab BB-232). As the MW rotated the nose down toward the MA, the MA's lift vector was on MW's aircraft with planform increasing (Tab R-3 and R-20) (See Figure 4.4).

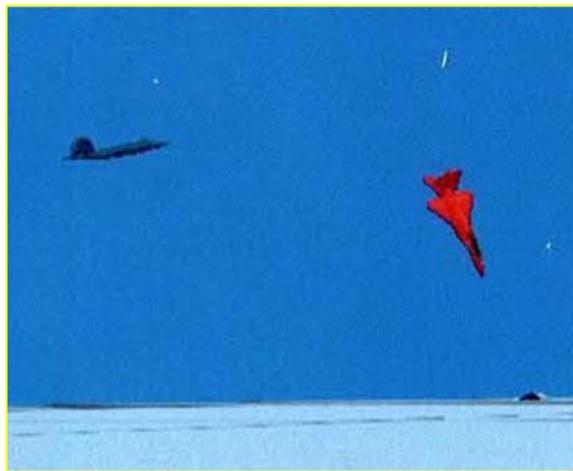
**Figure 4.5, 06:16:52L (Tab Z-5)**

The MW assessed increasing closure and decreasing range to the MA and executed a second nose high, climbing reposition (Tab R-21). The MP did not recall the change in flight path to the vertical, placing the MA lift vector onto the MW, nor pulling the nose of the MA to a high pitch attitude above the horizon and slowing to 105 KIAS (Tabs J1-9, V-2.8 to V-2.9, and V2.21 to V2.22). Rather, the MP perceived that the MA's turn rate had decreased (because the nose was not tracking across the horizon at the high AOA) and executed a fist width unload (forward stick) to break the AOA and get the nose tracking faster during the perceived right turn (Tabs V-2.3, V-2.10 and V-2.24). This action is consistent with executing a turn with rudder at high AOA, however, KITS data and MW testimony showed the MA in a nose high condition and no longer in a right hand turn (Tabs J1-8, R-3, and BB-236). From this steep pitch attitude, KITS data showed the MA began a right yawing nose drop from 65 degrees nose high and 20 degrees right bank to 65 degrees nose low and 110 degrees right bank (See Figure 4.5) (Tabs J1-8 and R-3). As the MA dropped below the MW's canopy line of sight during this reposition, the MW witnessed the MA's nose had begun to rotate down and to the right (See Figure 4.5) (Tab R-21).

While actual timing of the forward stick unload executed by the MP could not be determined, KITS data showed the MA entered a region of low to neutral pitch stability for the F-15C (0 to -10 AOA) as the MA's nose fell through the horizon (Tab J1-3 and J1-8). When the F-15C obtains an excessively nose-high pitch attitude, there is a possibility of a sudden nose-down pitch leading to a negative G excursion (Tab BB-234). Once the MA's nose was falling, the F-15C's lower pitch stability, assisted by gravity, explains the rapid nose down pitch rate that forced the MA into a negative AOA, negative G condition (Tab J1-10).

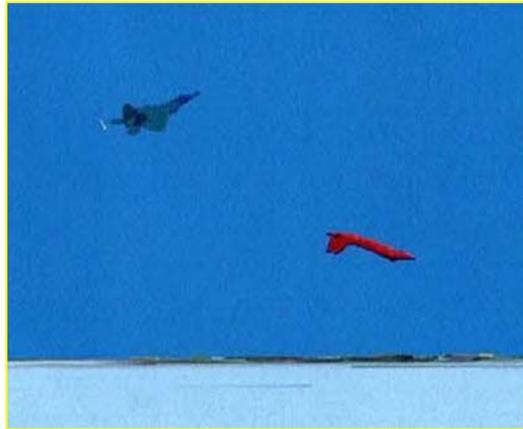
**Figure 4.6, 06:16:54L (Tab Z-5)**

KITS data confirmed a six-second nose drop followed by a negative AOA snap roll to the left (See Figure 4.6) (Tab J1-8). Parameters according to KITS data at the start of the snap roll were 145 KIAS, 65 degrees nose low, 110 degrees of right bank, 26 degrees AOA and -0.3 Gs (Tab J1-8 to J1-11).

The MP described it as an abrupt, uncommanded nose low maneuver in the opposite (to the left) direction of MP's flight control inputs (to the right) accompanied by departure warning tones (Tabs V-2.10 to V-2.11 and BB-248). An uncommanded, abrupt flight path change is the definition of a departure from controlled flight (Tab BB-247). According to the MP and analysis of the KITS data, the MA experienced a departure at this time (Tabs J1-4 and V-2.11).

Engineering analysis of the MA's flight trajectory concluded this departure was a negative G departure from controlled flight, with a snap roll to the left that transitioned to an inverted, negative G spin (Tabs J1-8 to J1-11, V-2.15 to V-2.16, BB-232, BB-254 to BB-255, DD-6 to DD-17, and HH-12). From the initial departure until MP's ejection (approximately 15 seconds), the MA exhibited 30 to 50 degrees per second range of right yaw, 100 degrees per second of left roll, decreasing but oscillating nose down pitch, -20 to -30 degrees AOA and -0.5 to -1.5 Gs (See Figures 4.6 to 4.8) (Tab J1-5, J1-8, and J1-10).
