DEPARTMENT OF THE AIR FORCE
AIR FORCE RESERVE

AIRCRAFT ACCIDENT INVESTIGATION A-10C, T/N 79-0164, WHITEMAN AIR FORCE BASE, MISSOURI 22 MAY 2013

SUMMARY OF FACTS AND STATEMENT OF OPINION

**A-10C, T/N 79-0164, WHITEMAN AIR FORCE BASE, MISSOURI
22 MAY 2013**

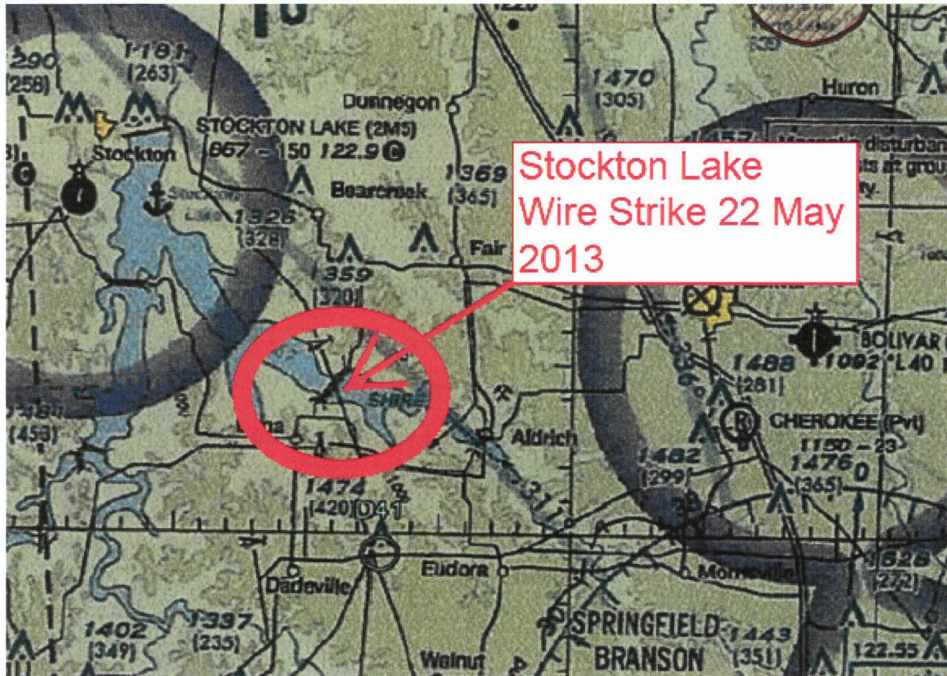
Close up of Stockton Lake mishap site on sectional map

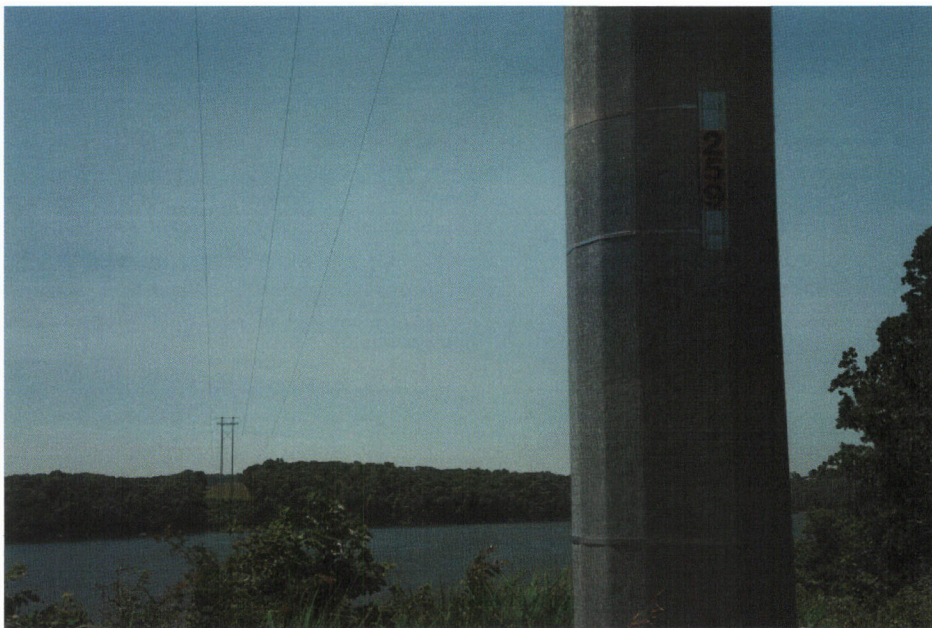
At 140 feet AGL, 3° of descent, approximately 10° left bank, heading 283°, and 299 knots indicated airspeed (KIAS), the MA impacted and severed two cables that spanned the lake (Tab S2).

View of mishap site towers and cables crossing Stockton Lake

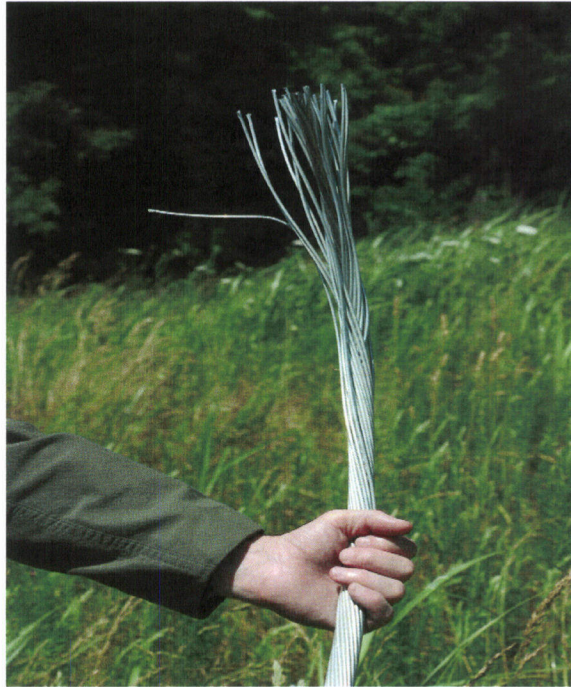
Severed cable at mishap site

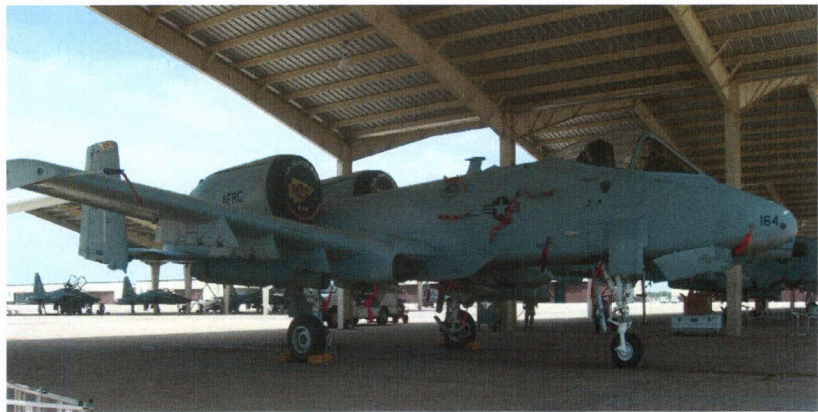
MA with visible damage to rudder cap and horizontal stabilizer

Review of the MA's AFTO 781 series forms and IMDS revealed all required maintenance actions were in compliance with standard operating procedures (Tab D2 to D4). Upon inspection of the damage on the aircraft, protective covers were installed to protect the aircraft from potential environmental damage, the effects of adverse weather, and foreign object ingestion. The MA was de-armed, impounded for investigation, and isolated in hangar 1117 with controlled access.

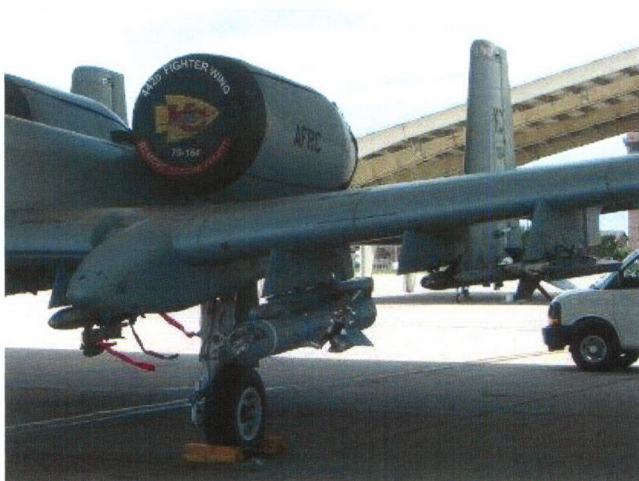
Overall, the aircraft suffered extensive damage from the cables that impacted the left side armament pylons. Additionally, the impact of the cables damaged training munitions. The aircraft returned to Whiteman AFB uneventfully after the mishap. The aircraft had damage to the right horizontal and vertical stabilizers (Tab S3).

Damage to BDU-33, TGM-65 Maverick, AIM-9, DRA

The MA impacted the cable on the front of the left wing across the training munitions and pylons. After initial impact, the damaged cable wrapped around the station 3 pylon which had a training TGM-65 Maverick missile. This training missile contained no explosive material. Its purpose is to use the seeker head and guidance system to practice targeting (Tab S3). Additionally, the Dual Rail Assembly (DRA) installed on Station 1 and training AIM-9 Heat-seeking Sidewinder missile loaded on the right rail of the DRA also sustained damage from initial impact with the cable (Tab S3). The AIM-9 training missile contained no explosive material and is used by the pilot to practice employment of the AIM-9. One BDU-33 had two stabilization fins knocked off, but none of the practice bombs were released during the mishap sortie (Tab S3). The 25-pound BDU-33 contains a small explosive charge that produces smoke for marking.

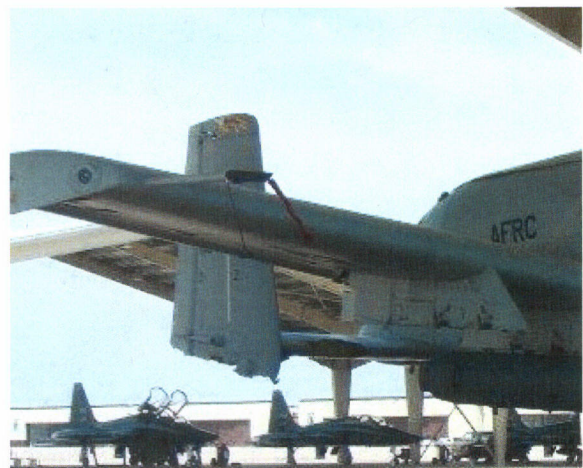
Damage to right vertical and horizontal stabilizer and right rudder cap

The MA experienced damage to the flight control surfaces due to debris and the cable stretching across the aircraft after initial impact, wrapping around the weapons pylons. The lower surfaces of the left speed brake, left wing cap, right horizontal and vertical stabilizers, and right rudder were impacted and sustained damage (Tab S3). Despite the visible damage, the MP maintained control of the MA and returned to base with no further events.

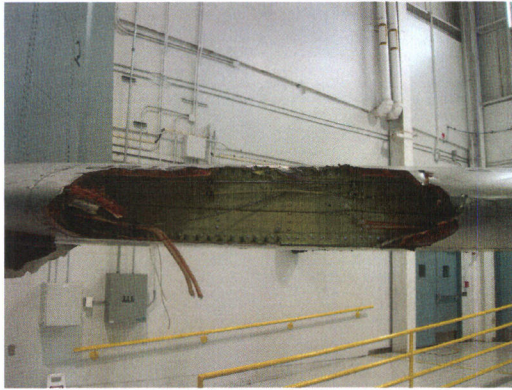
The MA has a left and right hydraulic system for primary and back-up control. The left system was intact. However, the cable struck the leading edge of the right horizontal stabilizer, removing a portion of the leading edge, and damaging the right system hydraulic line to the right rudder (Tab S3). The break in the line compromised the right hydraulic system to the point that the MP attempted to isolate it to prevent total hydraulic failure. With the right system failure, the MP had no control of the slats, speed brakes, and air-refueling door. The MP had control of the MA to land safely back at Whiteman AFB. Due to the break in the hydraulic line, the right system was depleted of fluid, driving the need to replace the right hydraulic pump.

Severed/damaged hydraulic, electrical (lighting), avionics, and manual flight control lines

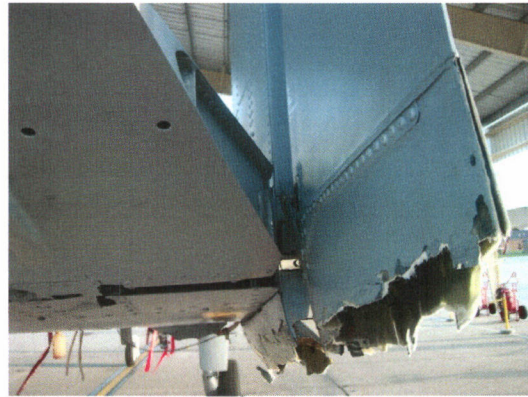
Damage to right rudder bottom cap and hinge
