**UNITED STATES AIR FORCE**  
**AIRCRAFT ACCIDENT INVESTIGATION**  
**BOARD REPORT**

**F-15E STRIKE EAGLE, T/N 90-0254**  
**391<sup>st</sup> FIGHTER SQUADRON**  
**366<sup>th</sup> FIGHTER WING**  
**MOUNTAIN HOME AIR FORCE BASE, IDAHO**

**LOCATION: SOUTHWEST ASIA**  
**DATE OF ACCIDENT: 3 MAY 2012**  
**BOARD PRESIDENT: COLONEL HENRY L. CYR**  
**CONDUCTED IAW AIR FORCE INSTRUCTION 51-503**

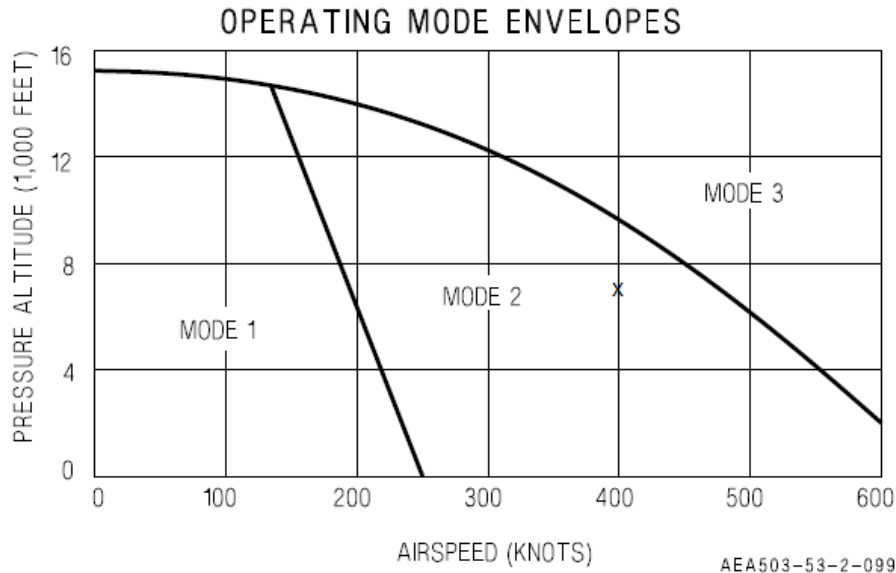
The MP initiated successful ejection within the performance envelope of the Advanced Concept Ejection Seat II (ACES II) ejection system. The MP experienced a Mode 2 ejection, while the MW experienced a Mode 1 ejection, despite the MA being well within the altitude and airspeed parameters for a Mode 2 ejection (see fig. 1). (Tab H-2-12)

Fig. 1. Digital Recovery Sequencer Mode Selection Criteria (MC's ejection parameters highlighted with an "X") (Tab H-2-12)

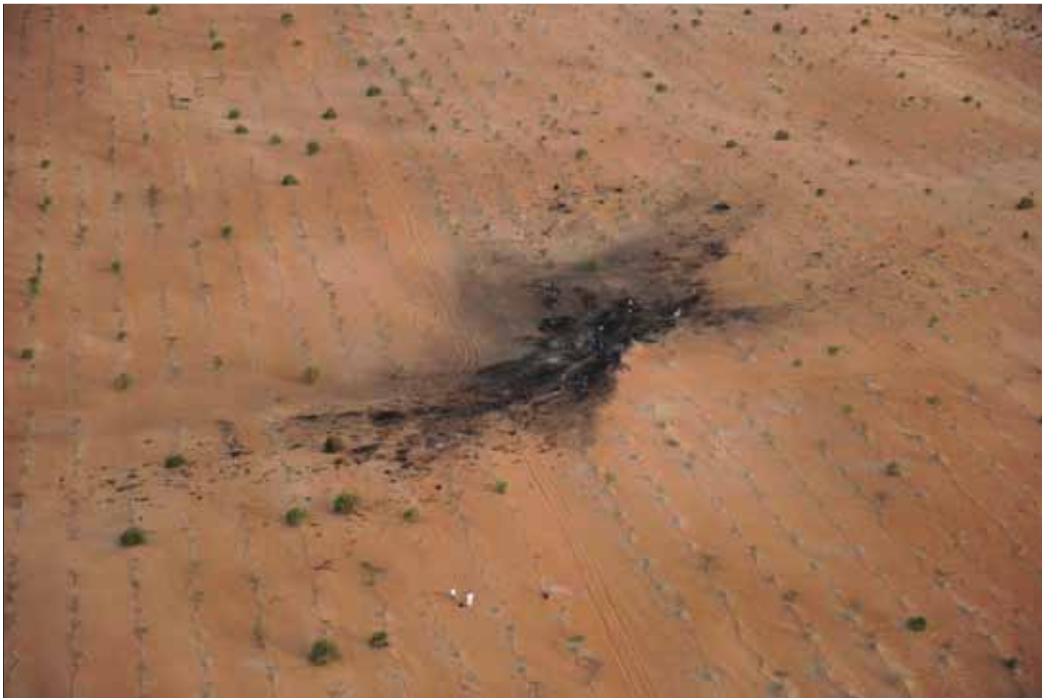
Upon impact, the aircraft created a scatter field measuring approximately 800 ft. by 1200 ft. (see fig. 3). The main wreckage consisted of a large crater with both engines still attached to the aircraft structure forward of the crater with both wings and left and right empennage sections nearby (see fig. 4). The forward and center fuselage sections were not identifiable at the wreckage site. The majority of the debris field was forward of the crater with small pieces of the wreckage surrounding the area in a radial pattern. Evidence of all flight control surfaces remained either installed or nearby to their respective airframe locations. (Tab J-45-53, H-105, J-88-110, J-225-276)

Fig. 3. Overview of Mishap Site (Tab S-4)

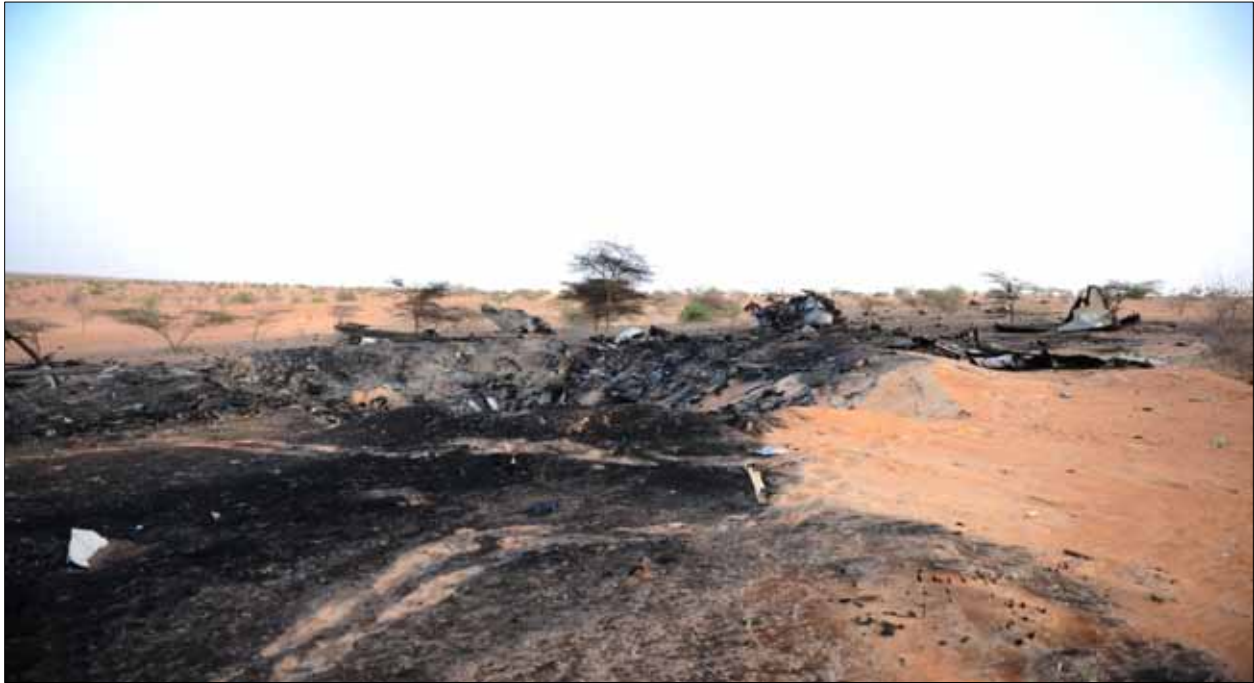
Fig. 4. Mishap Site Crater (Tab Z-2)

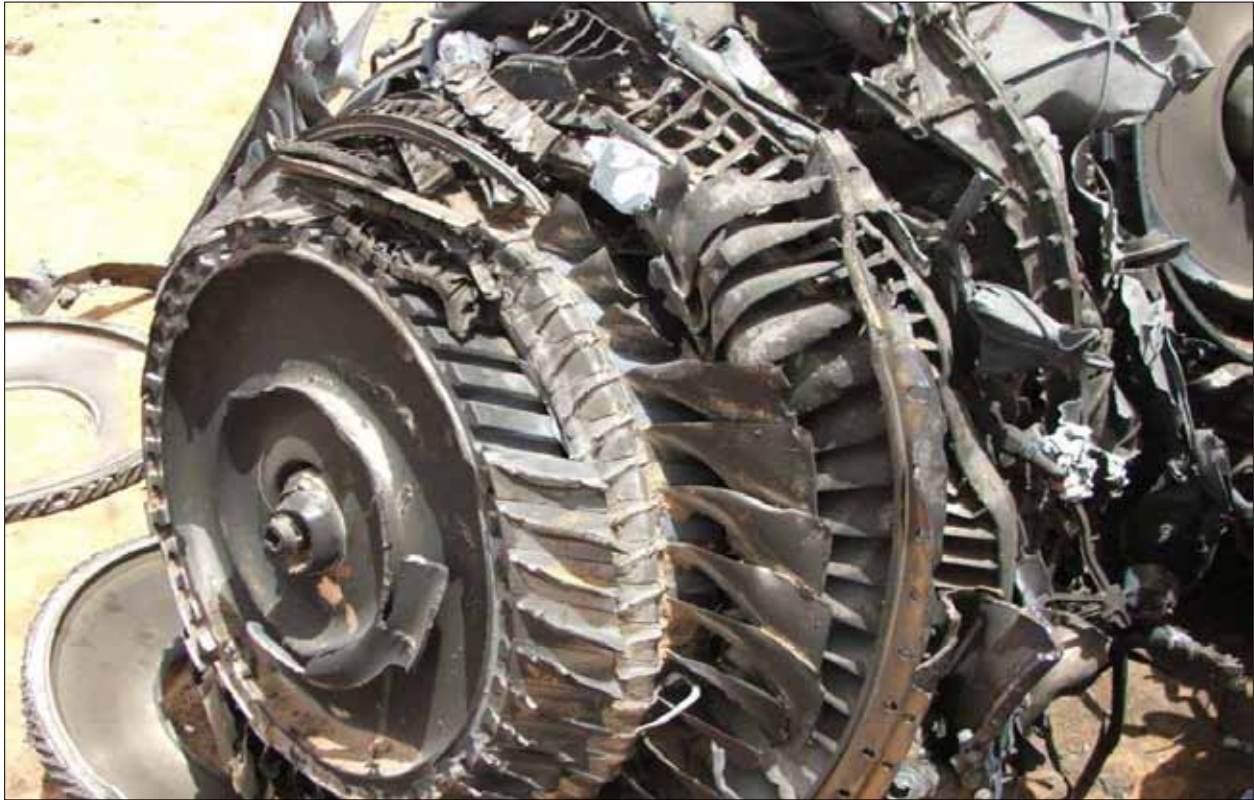
The number 2 engine (PW0E720172) showed evidence of a titanium fire in the compressor section. The engine was severed aft of the compressor split case, and evidence of the titanium fire was visible in the rear compressor section when reviewed at the mishap site. The engine was recovered and investigation focused on the Core Module and compressor section, and the hardware condition upstream of the compressor. (Tab J-88-110) The HPT and FDT were inspected internally using an Olympus iPlex borescope to establish the condition of these components. The IFM 2<sup>nd</sup> and 3<sup>rd</sup> stage blade disks remained with the rest of the engine (see fig. 5). There were numerous fan blades remaining in their respective positions in the 2<sup>nd</sup> and 3<sup>rd</sup> stage blade disks. (Tab J-88-110) Evidence from the IFM, HPT and FDT was used to determine the engine was wind milling at the time of impact. (Tab J-88-110)

Fig. 5. PW0E720172 Inlet Fan Module (Tab J-98)

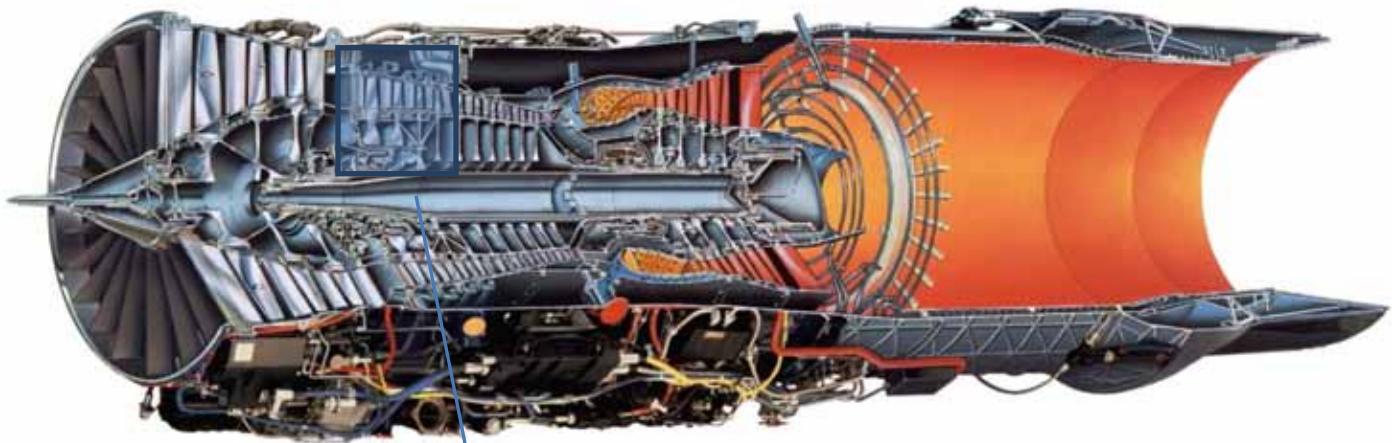
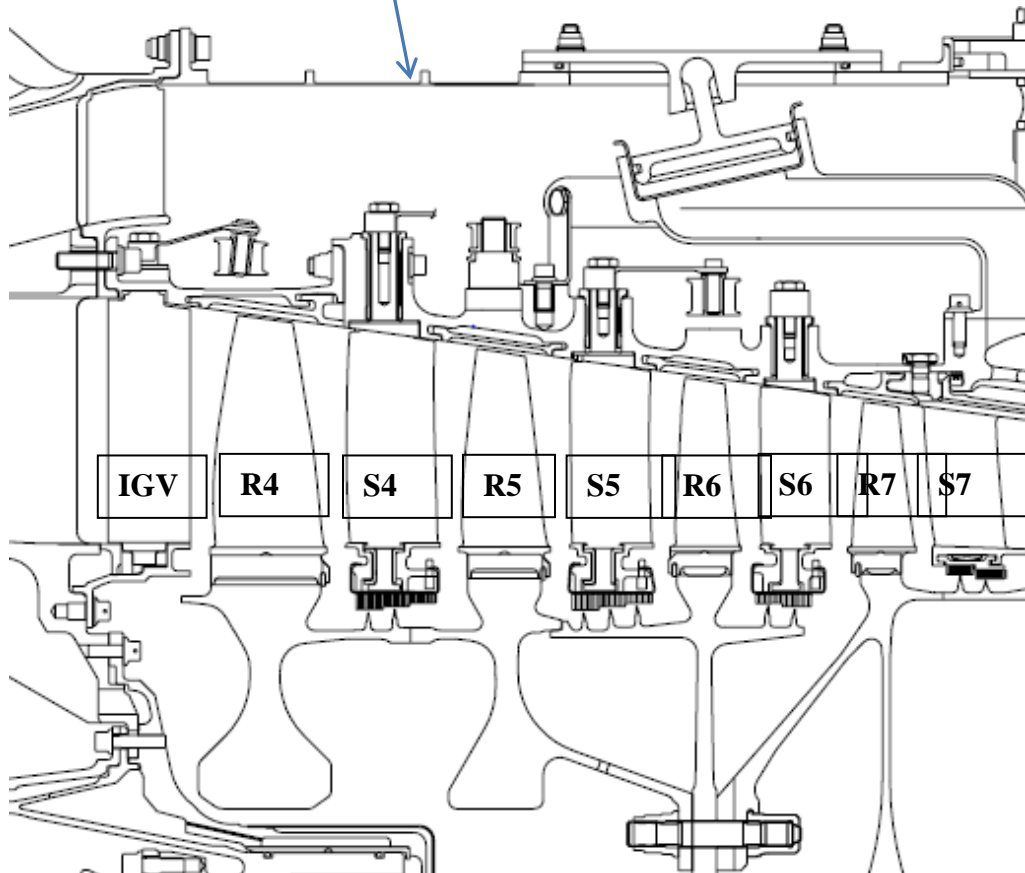
Post-mishap analysis localized the start of the titanium component fire to the 5<sup>th</sup> and 6<sup>th</sup> stages of the engine. Analysis was also able to determine the core of the mishap engine did not shift forward or rearward, eliminating one potential cause of the fire. The compressor case was removed for investigation. The 4<sup>th</sup> through 9<sup>th</sup> case was damaged by fire and impact. The case was severed by a titanium fire at both the 5<sup>th</sup> and 6<sup>th</sup> stage area, creating three separate pieces of the case. The 5<sup>th</sup> and 6<sup>th</sup> stage blade area was completely burned through for the entire circumference of the case, with the greatest damage at the 4 to 5 o'clock position, viewed aft looking forward. (Tab J-88-110) The 7<sup>th</sup> stage area was burned, but not through the case. The 8<sup>th</sup> through 13<sup>th</sup> stage area was not burned through, but had melted material covering the blade air seal abradable material. The abradable material in those locations did not display any blade tip rubbing other than what is normally seen in the compressor. When the radial location of the compressor is not maintained correctly during engine operation, (rotor/blade shift/imbalance or case displacement) the blades will contact the abradable material and create deep rubs; this was not evident in the mishap engine. (Tab J-88-110)

Fig. 6. Cross Section of the forward Portion of the High Pressure Compressor

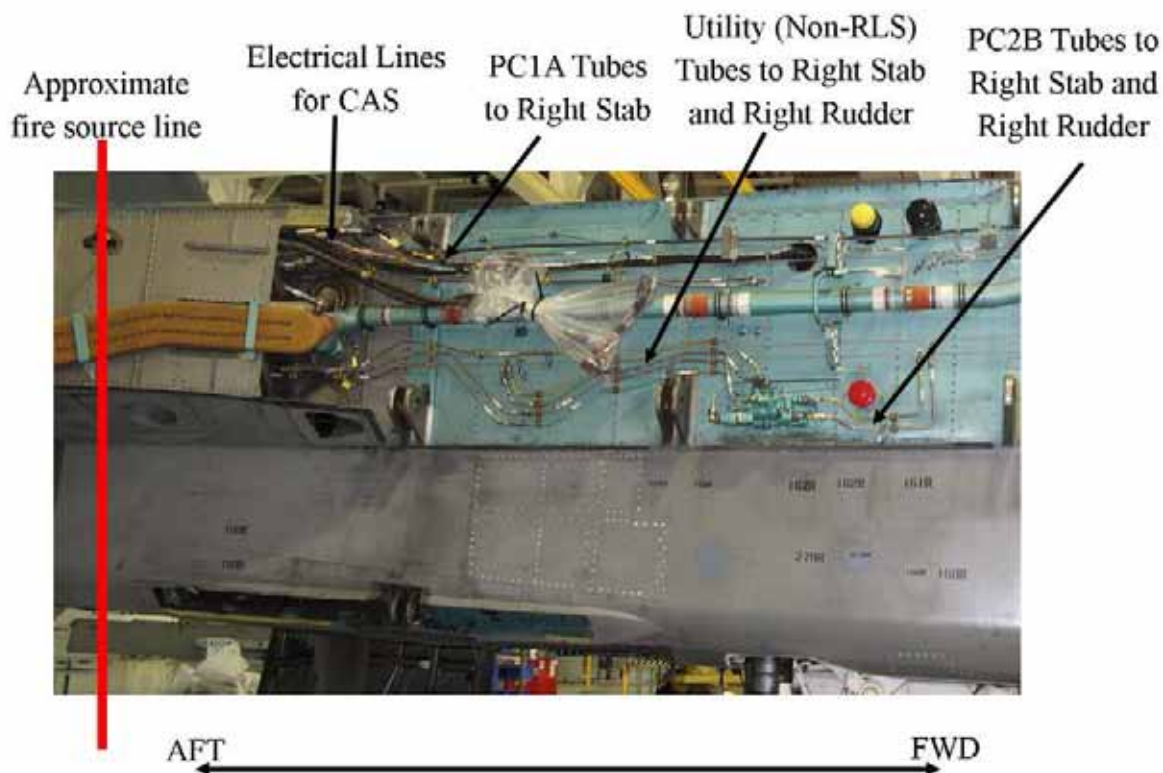
The evaluation of the right engine (PW0E710172) indicated an unidentified component failed for an unknown reason during normal engine operation. A titanium fire was initiated in the inner diameter of the compressor case in the 5<sup>th</sup>, 6<sup>th</sup> and 7<sup>th</sup> areas. Compressor material liberated and mechanically damaged all of the compressor blades aft of the 5<sup>th</sup> stage. The titanium fire at the 5<sup>th</sup> and 6<sup>th</sup> stage area in the split case burned through the compressor case for nearly the entire 360 degree circumference of the case. The titanium fire subsequently burned through the Front Fan Duct in numerous areas and into the aircraft engine bay. (Tab J-88-110)

Titanium fire duration of burn is dependent on operating conditions and is accompanied by temperatures as high as 6000 degrees Fahrenheit/3315 degrees Celsius. (Tab DD-8) The energy created by the fire destroys surrounding material, including steel and nickel alloys, by burning and melting. An “uncontained titanium fire” occurs when the fire burns through the engine casings and into the engine bay. (Tab DD-8-9) This can severely damage airframe structures and components resulting in degraded or complete loss of aircraft systems (see fig. 7). At high rotational speeds, an uncontained fire can burn through the engine case in a mere 10-15 seconds, depending on the casing material and thickness. (Tab DD-12)

The onboard fire extinguishing system uses Halon 1211 as the aircraft’s fire extinguishing agent. The F-15 fire extinguisher was designed to extinguish a typical fire associated with the ignition of combustibles such as fuel and oils, not a fire with the intensity of a titanium fire. (Tab DD-6) The fire containment system and firewalls are designed to withstand a 2000 degree Fahrenheit fire for 10 minutes, well below the 6000 degrees Fahrenheit experienced during a titanium fire. The system is for one time use and is not assessed to be an effective extinguishing agent for titanium fires. (Tab DD-6-12)

Fig. 7. Red line depicts likely burn-through location of titanium fire from engine bay in close proximity to PC1, PC2, and Utility hydraulic lines.
