**UNITED STATES AIR FORCE**  
**AIRCRAFT ACCIDENT INVESTIGATION**  
**BOARD REPORT**

**F-16C, T/N 00-0219**

**DATE OF ACCIDENT: 3 APRIL 2013**

**EXECUTIVE SUMMARY  
AIRCRAFT ACCIDENT INVESTIGATION**

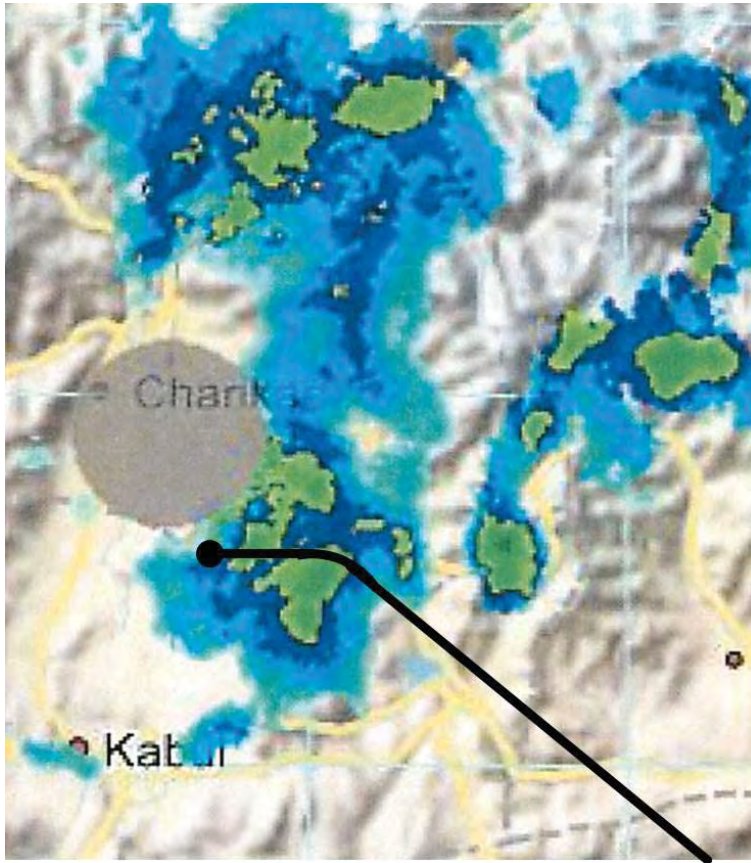
The MW testified that during RTB, there was an easily visible 16,000 foot AGL undercast and a thunderstorm to the northwest of their position (Tab V-1.36). The MF descended into and remained in IMC until the MA impacted the mountainside (Tab V-1.31 to V-1.37).

**Figure 1: Weather Radar Composite Reflectivity (2302L) and MF Flight Path (Tabs F-7, J-CSMU and M-2 to M-4)**

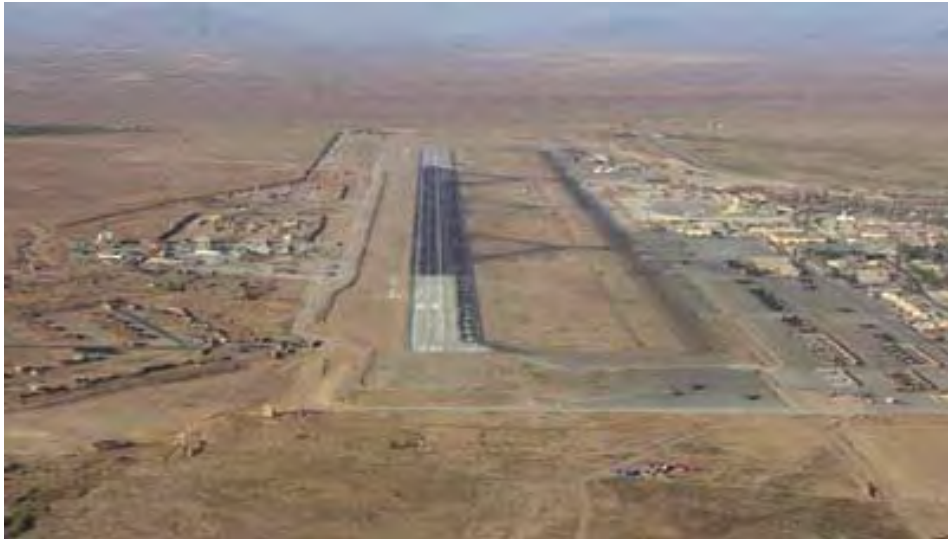
The MP and MW spent the first five months of their deployment flying out of KAF. The area around KAF had very little elevated terrain (Tab V-1.4 to V-1.6). Four days before the MF, the MP’s squadron moved to BAF, which has high terrain (Tab AA-3). The MF was only the MP’s second sortie flown out of BAF (Tab V-1.9 and V-1.19). As the MP flew 40 night approaches into KAF, and only one prior night approach into BAF, it is possible he reverted to a mental model of flat terrain (Tab G-12 to G-15).

**Figure 2: KAF (minimal terrain) (Tab Z-3)**

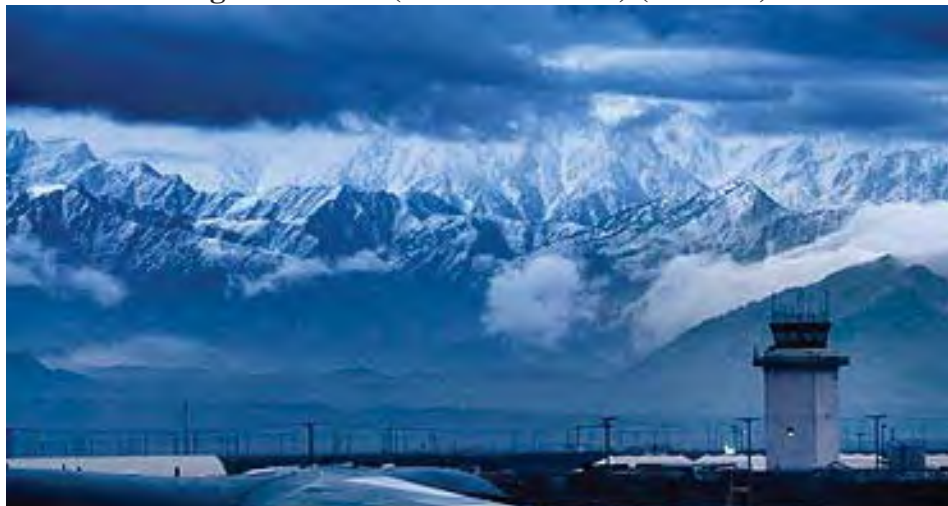
**Figure 3: BAF (mountainous terrain) (Tab Z-5)**
