UNITED STATES AIR FORCE
ABBREVIATED AIRCRAFT ACCIDENT
INVESTIGATION
BOARD REPORT

MQ-9, T/N 09-004065

26TH WEAPONS SQUADRON
57TH WING
NELLIS AIR FORCE BASE, NEVADA

DATE OF ACCIDENT: 5 December 2012

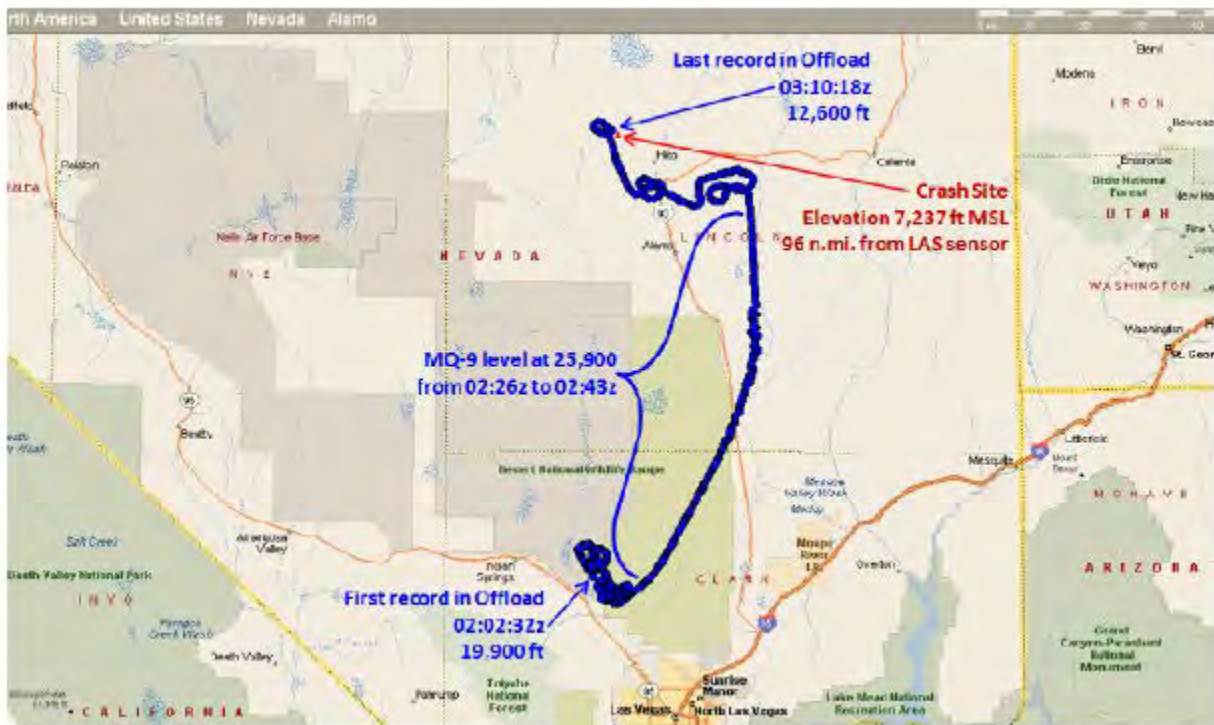
Figure 2. Map of Mishap Flight (Tab M-2)

At 03:09:41(Z), the MRPA was completely stalled at 68 KIAS, 29.5 units of AOA, a vertical velocity of -1,748 feet per minute descent, and the 100% detent command remained because the throttle was still at 96%. A few seconds later, the aircraft rolled to the left due to the left wing stalling out. At 03:09:53(Z), the MRPA attained an unrecoverable attitude and went lost link (Tab AA-7).

The MRPA impacted a non-residential area at 03:10:30(Z), (1910:30 L), approximately 3 miles northeast of Mount Irish, Douglas County, NV (Tab AA-7). The MRPA, one Guided Bomb Unit (GBU-38), a Hellfire training missile, a Mission Kit, and one M299 missile rail were destroyed. The total damage to United States (U.S.) Government property was assessed to be \$9,646,088 (Tab P-4). There were no injuries or damage to other government or civilian property reported (Tab P-3).
