UNITED STATES AIR FORCE
AIRCRAFT ABBREVIATED ACCIDENT
INVESTIGATION BOARD REPORT

MQ-9A, T/N 04-4011
11TH RECONNAISSANCE SQUADRON
432D WING
CREECH AFB, NEVADA

DATE OF ACCIDENT: 11 DECEMBER 2014

SUMMARY OF FACTS AND STATEMENT OF OPINION
MQ-9A, T/N 04-4011
11 December 2014

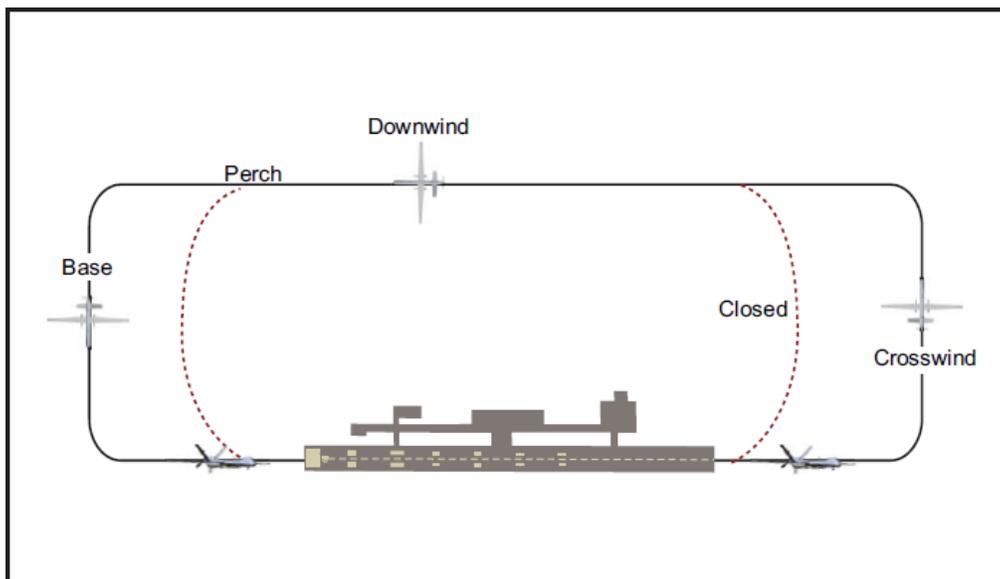
Figure 1 – Normal Visual Approach Pattern Segments (Tab BB-7)

During the two approaches prior to the mishap approach, the MRPA flew over terrain at low altitude, between 250 and 400 feet above ground level (Tab U-11).

During the mishap approach, the MIP directed the MSP to delay the turn to the base segment in order to extend the downwind segment of the pattern to align the MRPA with the runway farther out from the runway (Tabs N-30, V-2.2). The MSP reduced engine power to idle (Tab U-7). When the MSP initiated the descent, he decreased the pitch angle by lowering the nose of the aircraft, which caused the MRPA’s rate of descent to reach -1,200 FPM (Tab DD-2). Although the descent was already established, the MIP directed the MSP to increase the rate of descent (Tab N-30). The MSP commanded the nose of the MRPA lower and the rate of descent further increased to -2,300 FPM (Tab DD-2). Shortly thereafter, the MRPA reached a position where the data signal that is used to control the MRPA from the ground began to be obscured by terrain
