**UNITED STATES AIR FORCE**  
**ABBREVIATED AIRCRAFT ACCIDENT**  
**INVESTIGATION BOARD REPORT**

**MQ-9A, T/N 11-4129**

**LOCATION: AFGHANISTAN  
DATE OF ACCIDENT: 18 MAY 2015  
BOARD PRESIDENT: LIEUTENANT COLONEL DAWN JUNK**

**Conducted Pursuant to Chapter 11 of Air Force Instruction 51-503**

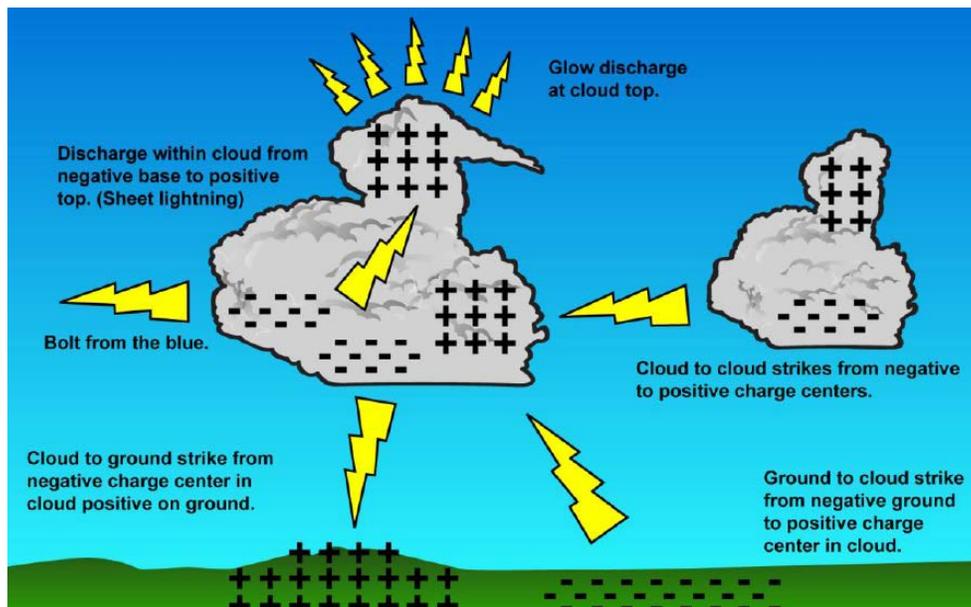
Figure 1: Lightning Variations (Tab BB-6).

According to Air Force Instruction (AFI) 11-203VI, *Weather for Aircrews*, 12 January 2012, lightning strikes and electrical discharges are the leading causes of reportable weather related aircraft accidents in the Air Force (Tab BB-7). Lightning occurs at all levels in a thunderstorm (Tab BB-6). The majority of lightning discharges never strike the ground but occur between clouds or within a cloud (Tab BB-6). Lightning also occurs in the clear air around the top, sides and bottom of storms (Tab BB-6). The aircraft itself can trigger electrical discharges very similar to natural lightning (Tab BB-7). Electrical charges build on the aircraft as it flies through clouds, precipitation or solid particles, such as dust or ice (Tab BB-7). The aircraft's electrical field may then interact with charged areas of the atmosphere resulting in an electrical discharge (Tab BB-7). Research has shown that aircraft more commonly trigger strikes or discharges when, among other conditions, it is in light precipitation (Tab BB-7).

Lightning strikes and electrical discharges have varied effects on aircraft (Tab BB-8). Typically, structural damage is minor but damage to aircraft electrical systems are common (Tab BB-8). MQ-9A pilots are to keep aircraft 25 nautical miles away from known thunderstorm activity (Tab BB-15). However, thunderstorms can move rapidly and form quickly in previously clear areas (Tab V-5.1). In the mountainous regions of Afghanistan, it is common for thunderstorm clouds to develop from a ceiling of 8,000 feet MSL up to 40,000 feet MSL in less than 15 minutes (Tab V-5.1). The MQ-9A has no built in protection against lightning and is not equipped with weather
