**UNITED STATES AIR FORCE**  
**AIRCRAFT ACCIDENT INVESTIGATION**  
**BOARD REPORT**

**T-38A, T/N 68-8153**

**UNITED STATES AIR FORCE TEST PILOT SCHOOL  
412TH TEST WING  
EDWARDS AIR FORCE BASE, CALIFORNIA**

**DATE OF ACCIDENT: 21 MAY 2009**

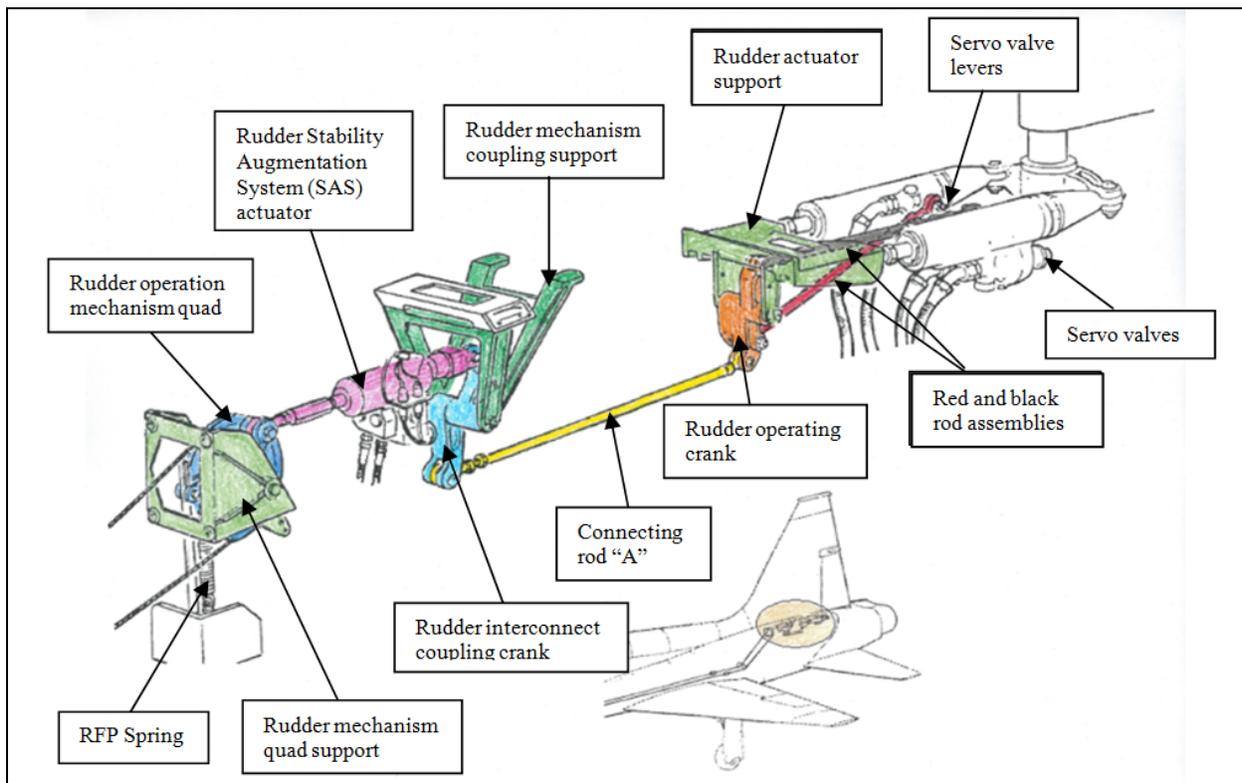
**Figure 2.** Rudder Operating Mechanism Critical Safety Items (CSI)

According to the Accident Investigation Board's technical advisor, the Air Force T-38 System Program Office's primary T-38 flight controls engineer, there are two possible causes of the rudder failure: 1) a structural break in a critical component or bolt, or 2) a maintenance error in which hardware such as a nut or cotter pin was not properly installed. In his opinion, it is highly likely that an improperly secured nut became unseated, disconnecting the flight controls from the rudder actuators. As evidenced by two other T-38 mishaps with 30 degree hardover rudder failures, both cases were absolutely proven to be the result of improperly secured fasteners on connecting rod "A" (Tab V-19.4). It is highly unlikely that mechanical fatigue, such as a bolt breaking, could have caused this failure (Tab V-19.4). The rudder is normally limited to six (6) degrees of deflection with the landing gear in the retracted position. In order for the rudder to be able to obtain 30 degrees deflection with the landing gear retracted, a component failure of a Critical Safety Item (Figure 2) must occur (Tab V-19.3).

The last documented maintenance actions on the rudder operating mechanism were during the last 900 hour major phase inspection from 20 October 2008 to 2 January 2009. It was also the last documented opportunity to discover and correct any maintenance deficiency within the rudder operating mechanism, either by the phase maintenance personnel (Tabs U-43 thru U-69, V-17.3, V-17.4) or Quality Assurance personnel (Tabs U-103 thru U-105, V-18.2). Anomalies with the Quality Verification Inspection (QVI) are discussed below under “Inspections.”

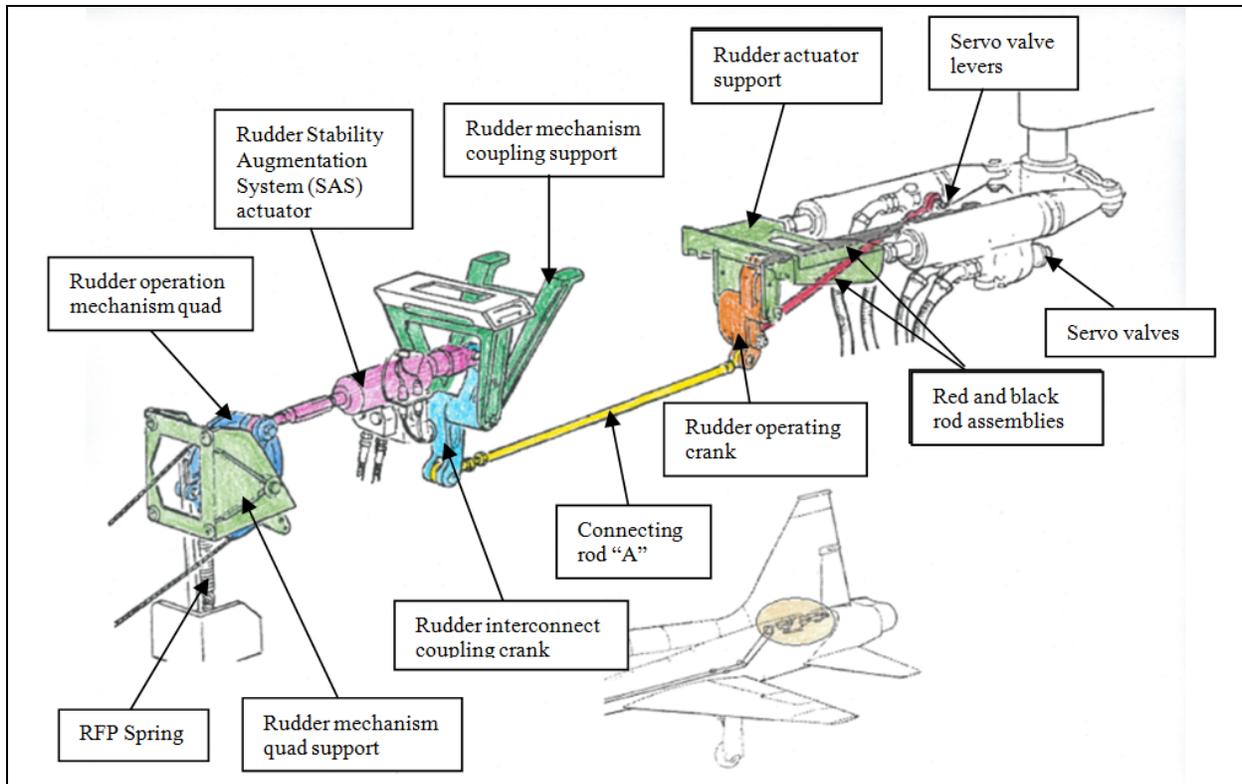
Rudder Operating Mechanism Critical Safety Items (CSI)

Based on analysis of the rudder actuators/control system, expert testimony from T-38 mechanical systems engineers confirms that the positions of both rudder actuators show the rudder was already at 30 degrees left full limit prior to impact, and not as a result of the impact. Due to the design of the rudder operating mechanism, the normal in-flight limit is 6 degrees; the only way to induce a 30 degree hardover rudder is to have a failure of a rudder critical safety item (see diagram, next page), to include the portion of the system between the rudder force producer spring and the rudder operating crank.

There are two possible causes of a rudder operating mechanism failure: either a structural break in a critical component or bolt, or a maintenance error in which a nut or cotter pin did not properly secure a bolt connecting two critical components.
