UNITED STATES AIR FORCE
AIRCRAFT ACCIDENT INVESTIGATION
BOARD REPORT

F-16CM, T/N 91-0364 & F-16CM, T/N 91-0365

**77TH FIGHTER SQUADRON
20TH FIGHTER WING
SHAW AIR FORCE BASE, SOUTH CAROLINA**

DATE OF ACCIDENT: 15 OCTOBER 2009

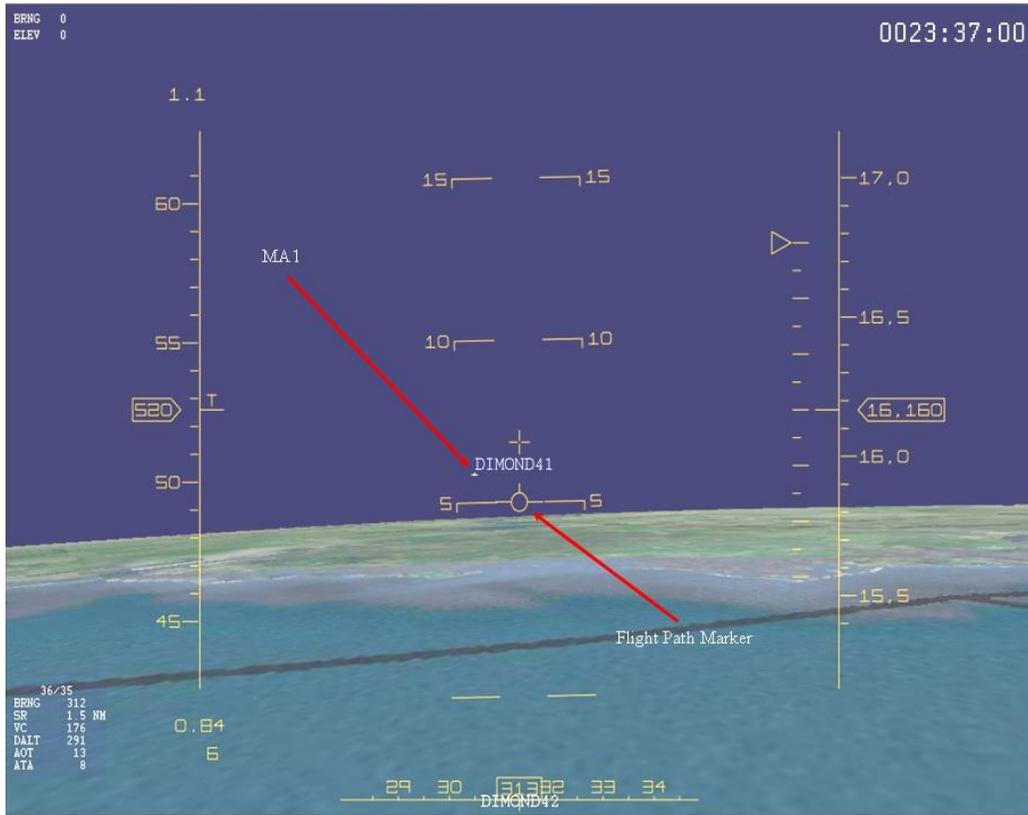
Figure 1

At 2023:37L, MA2 was 1.5NM behind MA1 at 397 KCAS maintaining MIL power. (Tab U-28) MA1 was almost centered in MP2's HUD, approximately 1.5 degrees from the flight path marker. The flight path marker shows where the aircraft is going. (See figure 1)

Note: Airspeed displayed in True Airspeed

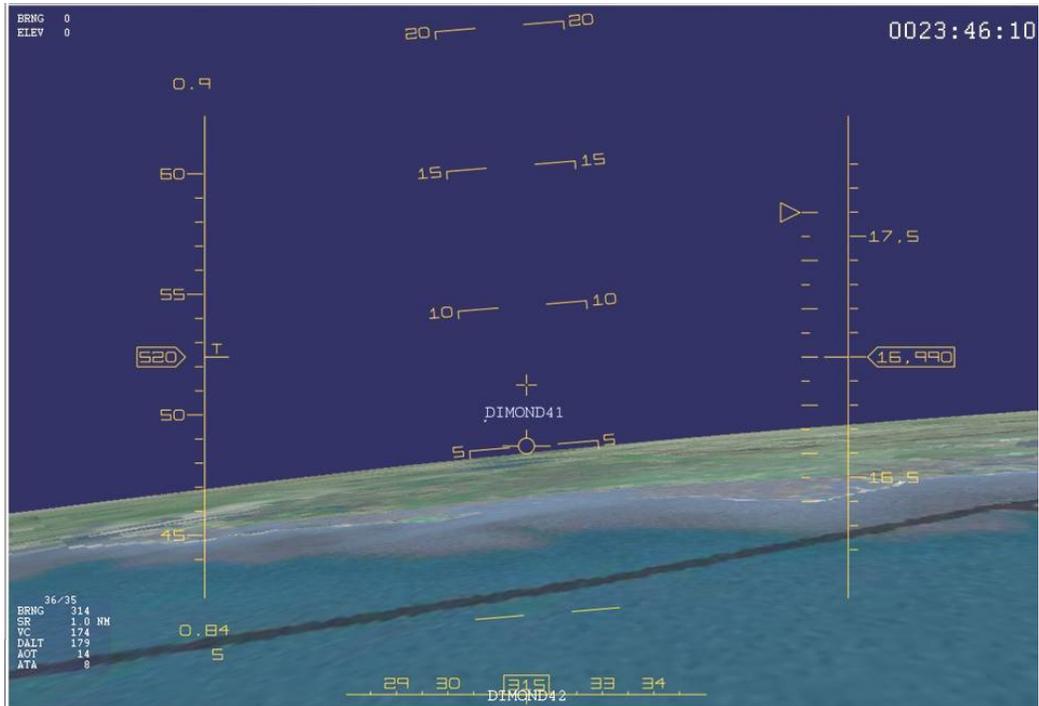
Figure 2

At 2023:46L, MP2 was 1NM from MA1 at 391 KCAS in MIL power with the same flight path relative to MA1. (Tab U-28) (See figure 2)

Note: Airspeed displayed in True Airspeed

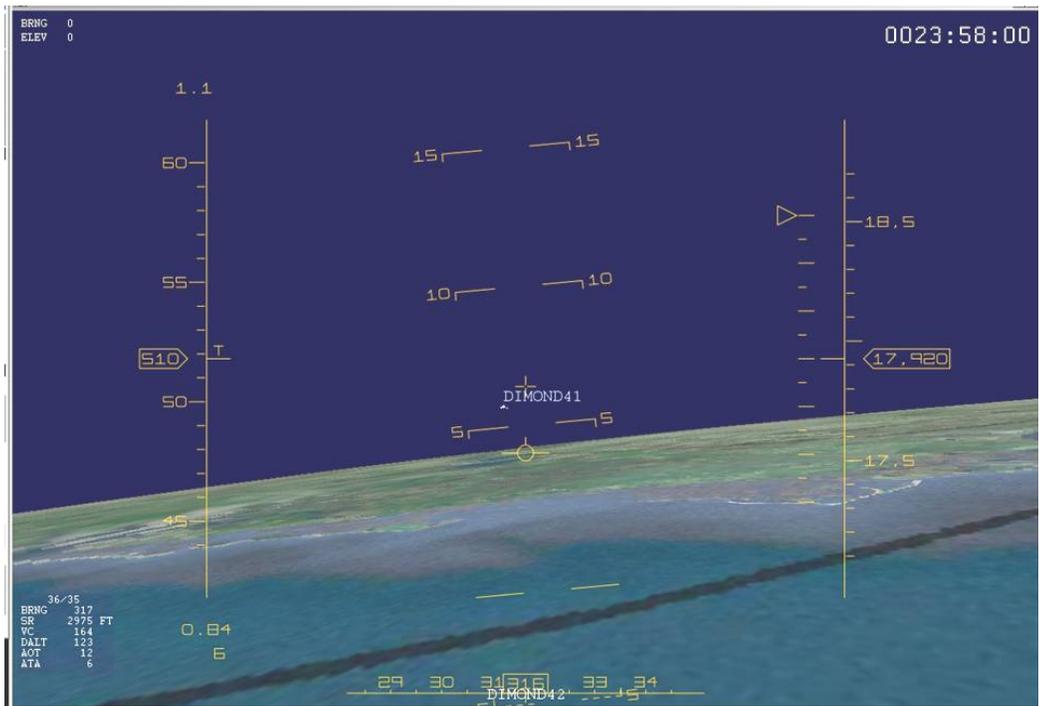
Figure 3

At 2023:56L MP1 set a 20 degree right hand bank and MP2 began to match that bank at 2023:58L. By 2023:58L, MP2 resumed MIL power following a 10-second slight power reduction. He was 3,000 feet from MA1 at 381 KCAS with 164 knots of closure with the same relative flight path. (Tab U-28) (See figure 3)

Note: Airspeed displayed in True Airspeed

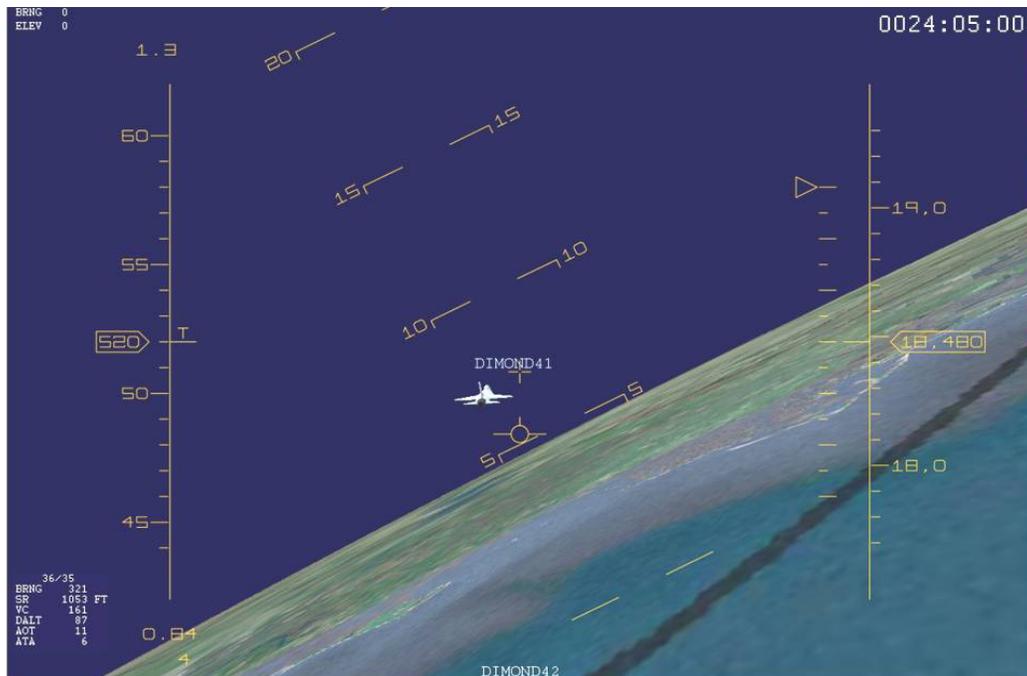
Figure 4

At 2024:05L, MP2 was 1,000 feet from MA1 with no change in airspeed, power setting, closure, or relative flight path. (Tab U-28) (See figure 4)

Note: Airspeed displayed in True Airspeed

At 2024:07.5L MA2 was 512 feet from MA1 with 159 knots of closure flying directly toward MA1. (Tab U-28) MA2 encountered wake turbulence from MA1’s right wing tip causing MA2 to roll right and increase angle of attack (AOA). MP2 made control inputs and reduced power consistent with countering this wake turbulence. (Tabs J-4, AA-32)

MA2 collided with MA1 at 2024:08.8L. (Tabs J-4, J-5, U-19, AA-32) MA2’s canopy struck MA1’s left horizontal stab then impacted MA1’s left SUU on weapon station 3. MA2 had approximately 15 degrees of left roll causing the right wing tip to contact MA1’s right horizontal stab. Finally, MA2’s vertical stabilizer impacted the left one third of MA1’s horizontal stab sheering the outer one third off and then contacted MA1’s left trailing edge wing tip just inside of the outboard missile rail launcher. (Tab J-4)
