NATIONAL TRANSPORTATION SAFETY BOARD
Office of Aviation Safety
Washington, DC 20594

AIR TRAFFIC CONTROL GROUP FACTUAL REPORT

OPS11IA246AB

A. AIRCRAFT INCIDENT

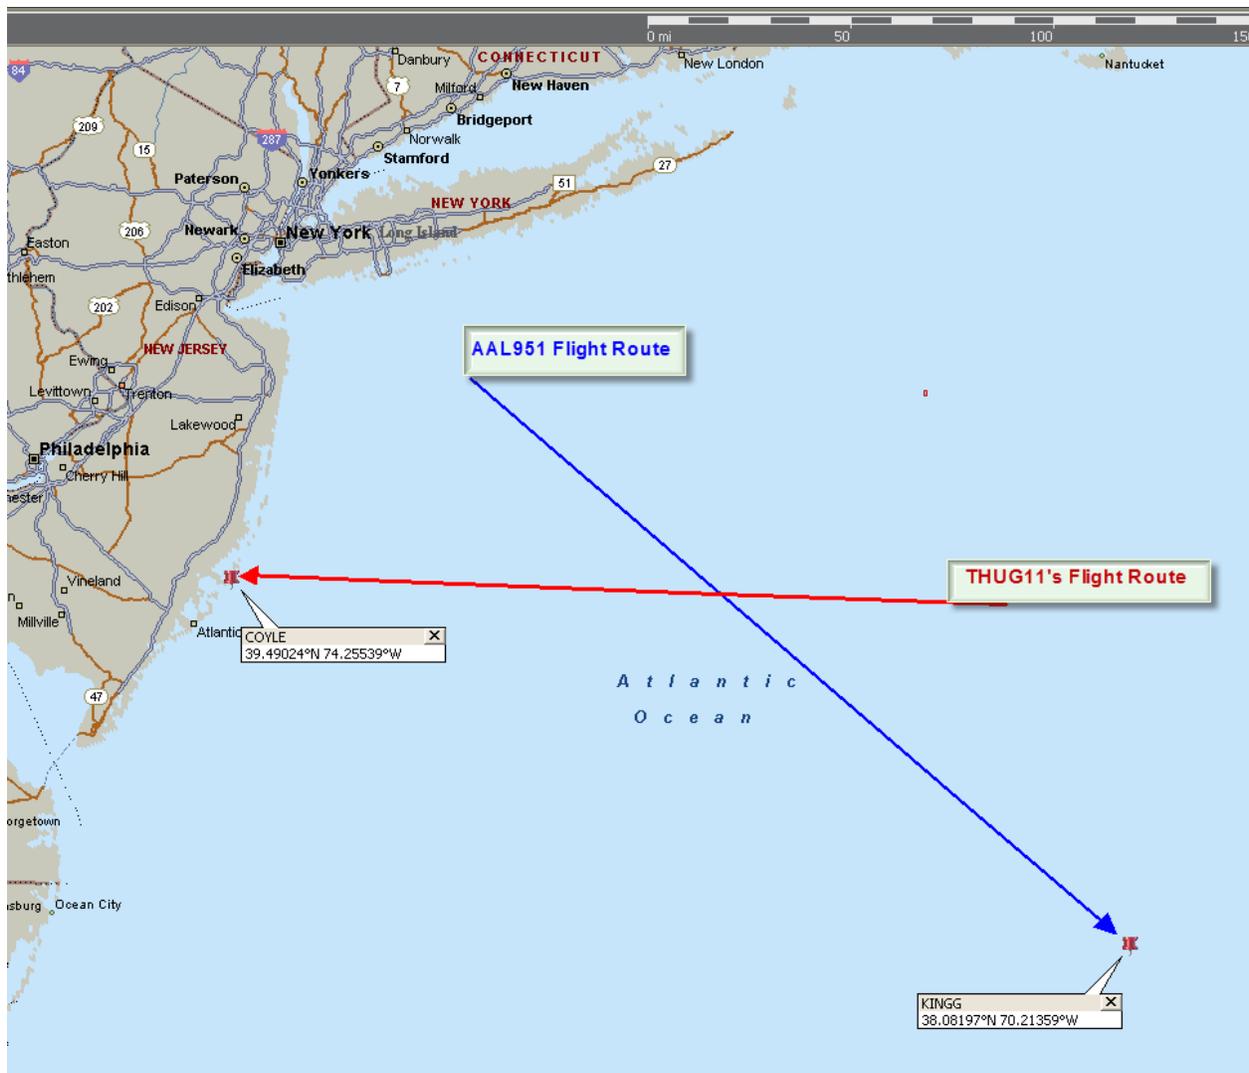
THUG11 was on a westerly heading to cross COYLE, and AA951 was on a southeasterly heading direct to KINGG. Figure 1 illustrates the KINGG and COYLE fixes and AAL951 and THUG11's routes of flight.

Figure 1. AAL951 and THUG11 proceeding direct to KINGG and COYLE, respectively.

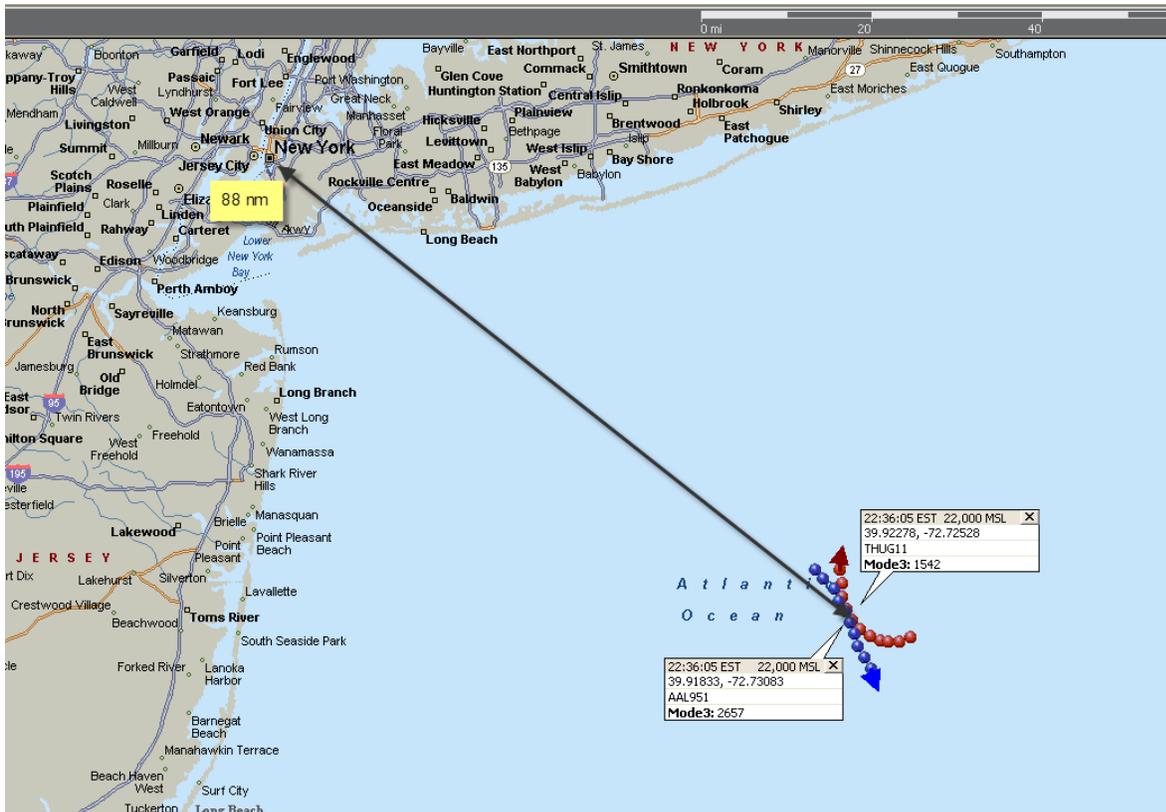
Radar data for this report was obtained from the Islip ASR-9 sensor located 0.75 miles northeast of Long Island MacArthur Airport, Islip, New York. Figure 2 shows a graphic overview of the flight paths of AAL951 and THUG11, and Figure 3 shows a close-up view of the minimum separation between the two airplanes. At the closest point, the aircraft were separated by approximately .38 nautical miles laterally and 0 feet vertically.

Figure 2. Overview of flights, including distance from New York City.

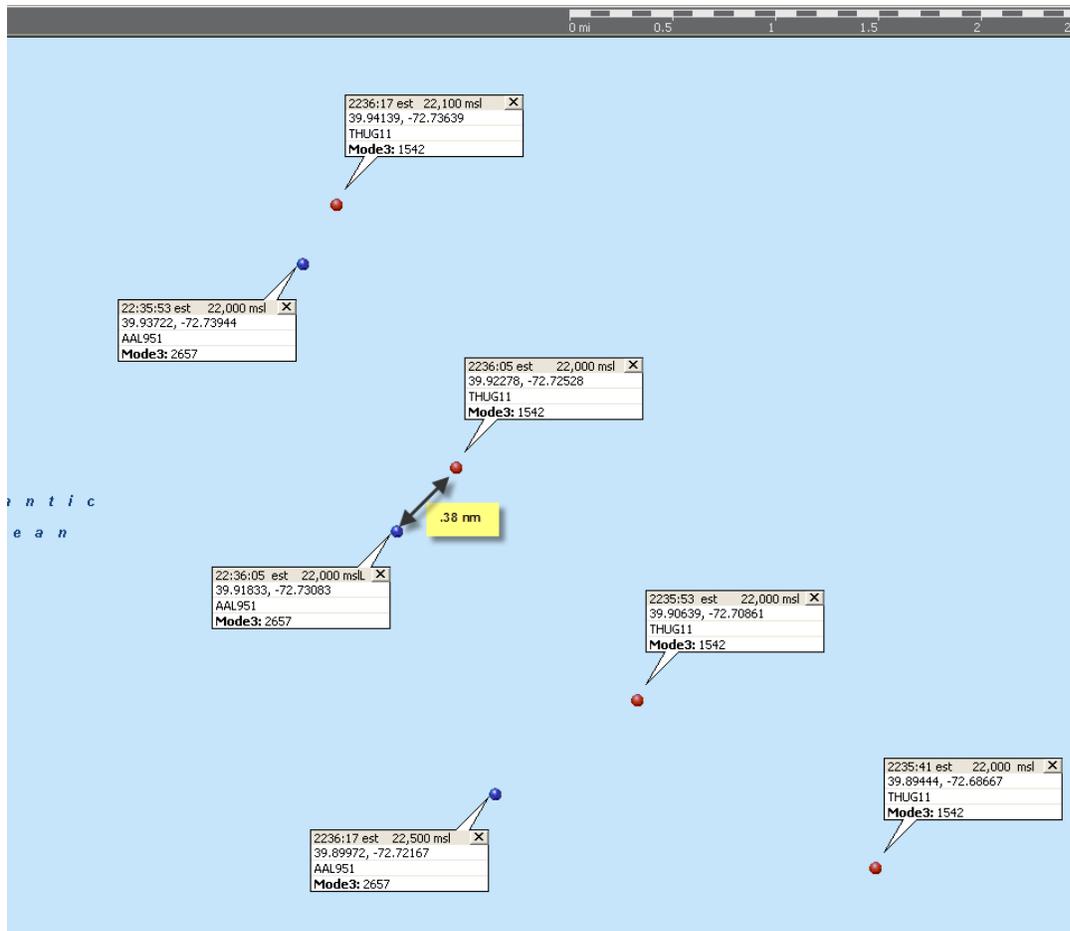
Figure 3. Close-up view of flights.
