UNITED STATES AIR FORCE
AIRCRAFT ACCIDENT INVESTIGATION
BOARD REPORT

F-16C, T/N 87-0296
100TH FIGHTER SQUADRON
187TH FIGHTER WING
DANNELLY FIELD, AL

LOCATION: OSHKOSH, WI
DATE OF ACCIDENT: 28 JULY 2011
BOARD PRESIDENT: COL MICHAEL R. KELLEY
CONDUCTED IAW AIR FORCE INSTRUCTION 51-503

SUBJECT: Accident Investigation Board Report: F-16C, T/N 87-0296, Oshkosh, WI,
28 July 2011

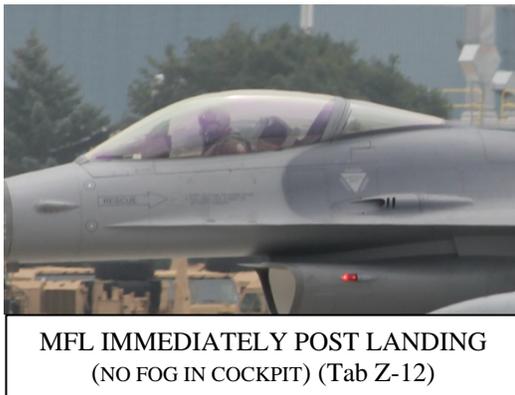
MFL IMMEDIATELY POST LANDING
(NO FOG IN COCKPIT) (Tab Z-12)

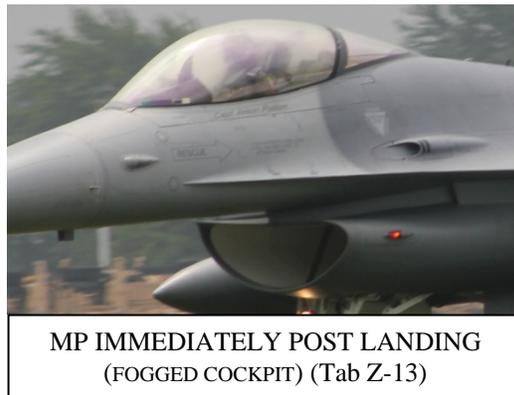
Cockpit ECS fog started developing in the MA as it approached the flare. As the throttle was retarded to idle, fog began to envelope the entire cockpit (Tab V-1.5, Z-13). As the MP began to set a pitch attitude for the aerobrake passing through 10-11 degrees, he lost sight of the HUD gun-cross and was unable to use the Nose Wheel Steering (NWS) indicator and AOA indexers for a visual reference (Tab V-1.5, V-1.12). CSFDR data indicates that the aerobrake varied between 5 and 11-degrees AOA during the rollout (Tab DD-26 – 28). The MP started losing forward visibility first (Tab V-1.5). Using the view out the side of the canopy, the MP focused on keeping the aircraft tracking down the runway (Tab V-1.5). The MP reached for the DEFOG lever and shoved it full forward (Tab V-1.5, 1.12). He held it in that position for one or two seconds with no effect and then recycled, with yet again no change in ECS fog or airflow (Tab V-1.5, 1.12). The MP then experienced brief vertigo, almost a tumbling sensation, and considered ejection but was concerned for spectators and aircraft along the runways (Tab V-1.5). The MP did not consider initiating a go-around because of the disorientation and no assurance that the ECS fog would dissipate, rendering the MP blind while navigating through the congested traffic pattern (Tab V-1.15).

MP IMMEDIATELY POST LANDING
(FOGGED COCKPIT) (Tab Z-13)

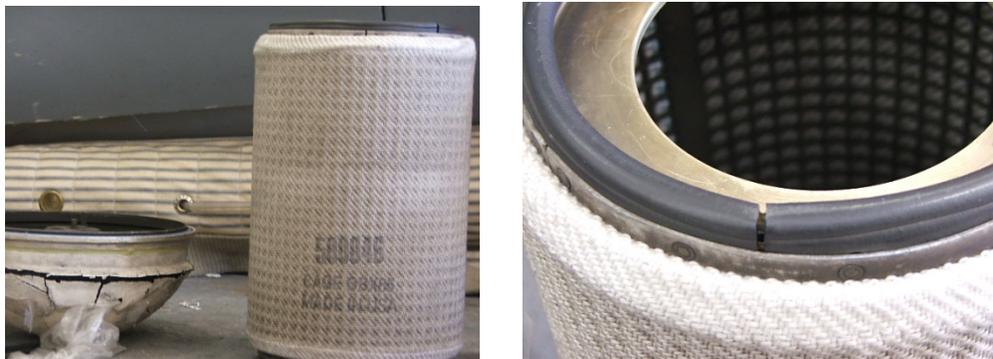
(4) Water Separator Coalescer

The coalescer collects and removes water from the air leaving the cooling air turbine compressor (Tab BB-18). The coalescer bands hold the coalescer tightly in place over the support grid through which the air must flow inside the separator (Tab BB-18). The top and bottom gaskets of the support grid show signs of wear, which will allow air to escape from the separator without removing the moisture (Tab Z-6). This condition will cause excessive moisture to buildup and transfer to the cockpit causing a fog condition (Tab Z-13). The fog condition will impair the pilot's vision and the ability to see outside the cockpit and read instruments (Tab Z-6).
