UNITED STATES AIR FORCE
AIRCRAFT ACCIDENT INVESTIGATION
BOARD REPORT

F-15C, T/N 80-0041
NELLIS AFB, NV

LOCATION: NELLIS AFB, NV
DATE OF ACCIDENT: 24 OCTOBER 2011
BOARD PRESIDENT: LT COL DYLAN WELLS
Conducted IAW AFI 51-503, Aerospace Accident Investigations

F-15C, T/N 80-0041 ACCIDENT NELLIS AFB, NEVADA 24 OCTOBER 2011

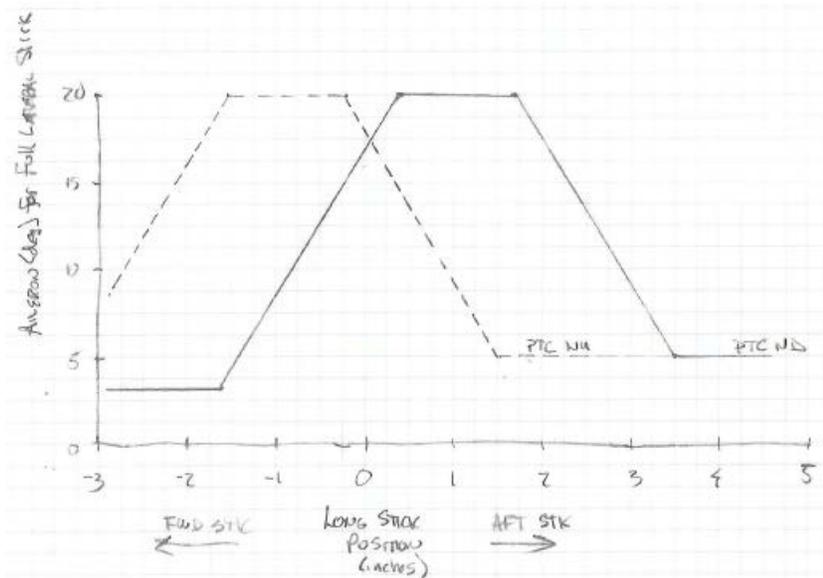
Figure 9. Lateral Ratio Changer Schedule

- Based on this figure, which assumes that the gear is up and that the full spin recovery logic is not enabled, the amount of aileron deflection provided is a function of the what the Pitch Trim Compensator (PTC) commands as well as the longitudinal stick position (in inches). The PTC provides the capability of automatically trimming the aircraft based on the desired stick force selected by the pilot. (Tab AA-28) Forward stick input causes the PTC to run towards its nose-down limit. Aft stick input causes the PTC to run to its nose-up limit. Even in a spin, the PTC is still fully functional and sees stick movement as a change in commanded G-level, and tries (unsuccessfully in a spin) to automatically trim the aircraft. Because of this, the PTC affects the Lateral Ratio Changer schedule which adjusts aileron deflection, affecting the pilot's ability to obtain full control authorities, regardless of stick position. (Tab GG-13)

- The MP testified that despite full left lateral stick input and differential throttles, he perceived no changes in the yaw rate warning tone or any sign that the jet was recovering. (Tab V-1.26) This could be due to unintentional aft input on the stick – a situation that was simulated and analyzed. This is also a natural tendency corroborated by discussions with F-15 test pilots, based on the forces experienced. In the simulator, being aft of longitudinal neutral as opposed to forward consistently produced longer or no recovery. (Tab GG-9)
