UNITED STATES AIR FORCE
GROUND ACCIDENT INVESTIGATION
BOARD REPORT

TYPE OF ACCIDENT: SUN SHELTER COLLAPSE
LOCATION: NELLIS AFB, NV
DATE OF ACCIDENT: 8 SEPTEMBER 2011

United States Air Force Ground Accident Investigation Board Report
Sun Shelter Collapse
Nellis AFB, NV
8 September 2011

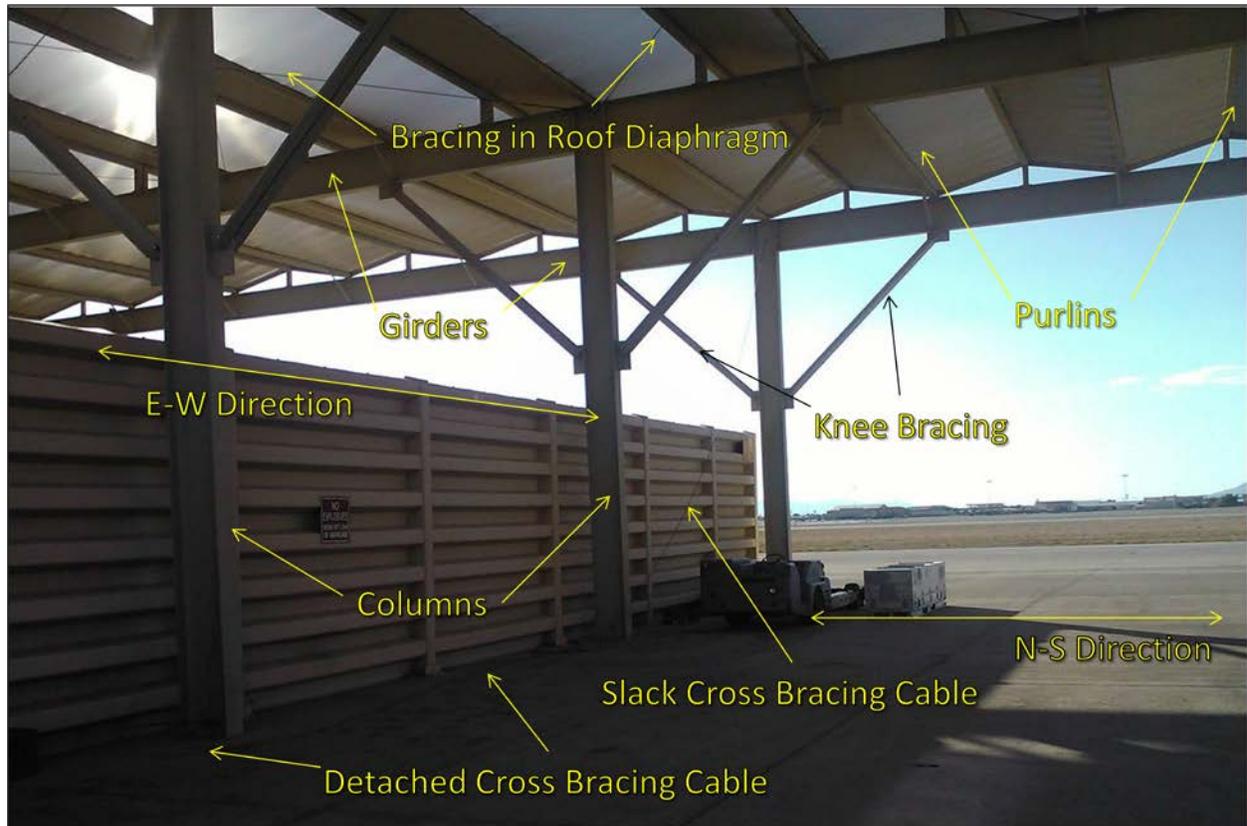
Figure 2. Condition Before Collapse

Photos taken of the sunshades over revetments 16-18, 21, and 23 show examples of the disrepair of the sunshades prior to the collapse. Of the 18 E-W cross-bracing cables visible in the pictures, 6 were slack (all east wind-resisting) and 6 were detached (all west wind-resisting) (Tab Y-6 – 11). Of the 16 structural diaphragm cross-bracing cables, 3 were slack or disconnected (Tab Y-12). Two column base plates showed significant prying deformation and loosening of the nuts on the anchors (Tab Y-13 – 14). Consistent with these failures and deformations, the eastern column in revetment 17 appears to have drifted out of plumb to the east (Tab Y-15). A 57th Wing Safety inspection of the revetment sunshades in February or March 2011 noted at least one damaged, slack, or detached cable in the E-W cross-bracing in each of the column rows in revetments 13-22 (Tabs BB-8, V-7.3).

Given the condition of the sunshade as described above, the structure's resistance to wind loads in the N-S direction would have been slightly reduced due to the condition of the diaphragm cables, but the majority of the capacity would remain due to the knee bracing. In the E-W direction, however, the designed wind resistance came solely from the four cross-bracing cables, and only two of these cables would be engaged in tension by a given direction of wind loading. As the photographic evidence reference above shows, both cables to resist a west wind were missing in each of the column rows of revetments 16, 17, and 18. Thus, the designed west wind bracing was certainly non-existent in those revetments and may have been reduced or non-existent in other revetments (Tab BB-8).

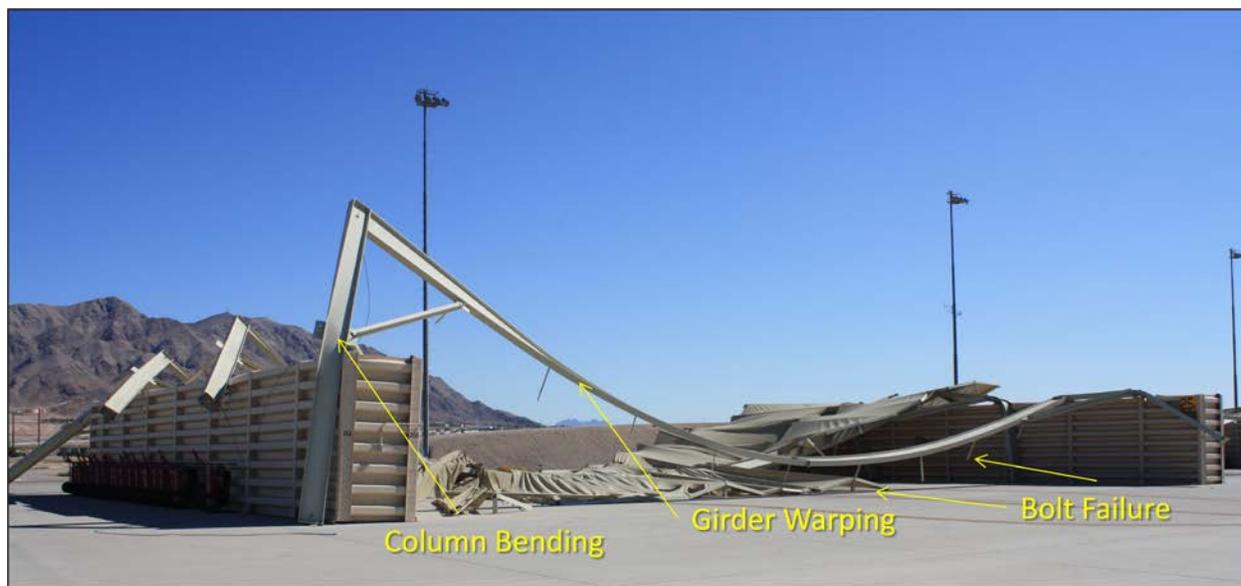
Figure 3. Condition After Collapse

The entire sunshade structure drifted to the east and fell, coming to rest on the revetments, aircraft parked under the sunshades, GOVs parked in the vicinity of the sunshades, or the ground (Tab Y-16 – 19). The column base plate assemblies generally exhibited a complete tension failure of the adhesive of the windward post-installed anchors, crushing of the concrete surrounding the leeward post-installed anchors, warping of the base plates, and/or failure of the windward column-base plate welds (Tab Y-20 – 22). Most columns also deformed, bending about their weak axis near the midpoint (Tab Y-23). Nearly all west wind cable bracing failed at the eye splice or by eyebolt straightening (Tab Y-24 – 25). The girders exhibited significant torsional warping, (i.e. twisting) though the column-girder joints, girder butt joints, and knee

bracing and respective connections were all intact (Tab Y-26 – 27). The majority the purlin-girder bolts failed in tension, breaking and scattering hundreds of bolt heads and nut-bolt thread assemblies across the surrounding area (Tabs BB-8 – 9, Y-28 – 29).
