**UNITED STATES AIR FORCE**  
**AIRCRAFT ACCIDENT INVESTIGATION**  
**BOARD REPORT**

**F-35A, T/N 12-005053**

**58TH FIGHTER SQUADRON**

**DATE OF ACCIDENT: 19 MAY 2020**

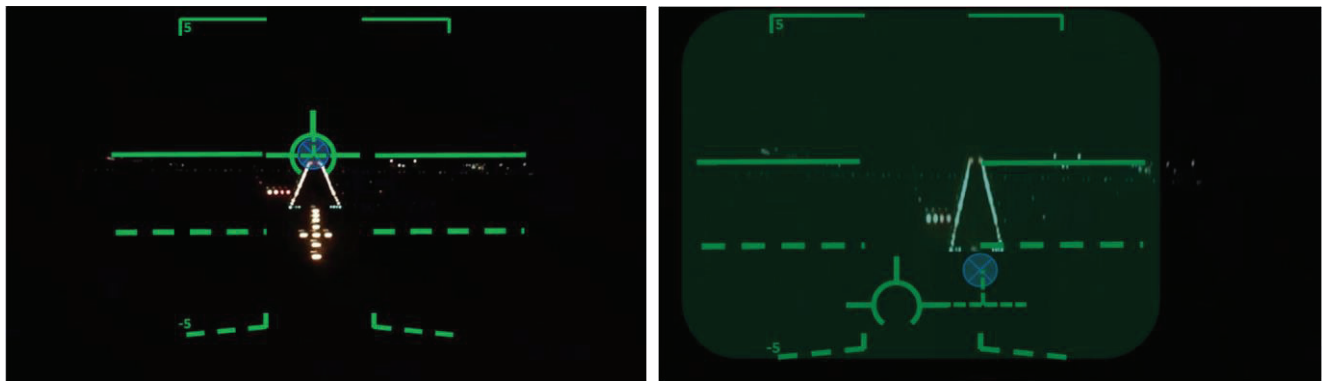
The HMD misalignment was undetectable during the sortie until this point (Tab V-1.6). However, once the MP pushed the nose of the aircraft down to set his aimpoint on the runway, the one degree nose low attitude could be clearly seen against the backdrop of the runway (Tab V-1.6). All this occurred during the final moments of flight, and coincided with the point in the approach when the MP normally engages APC and sets speed (Tab V-1.26). This was the first time the MP had experienced an HMD misalignment at night (Tab V-1.6 and V-1.34). The MP had also not experienced an HMD misalignment in a simulator before (Tab V-2.17).

**Figure 1**  
**Side by Side representation of Aligned HMD vs. Misaligned HMD with L-R crosswind, “Hand of God” phenomenon, “Green Glow,” and aimpoint in “black abyss” (Tab Z-7 and Z-27)**

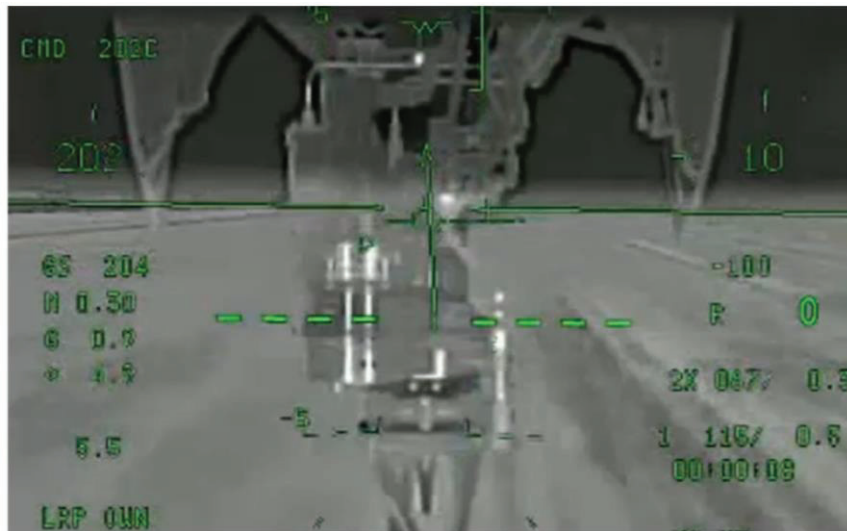
The MP touched down with Speed Hold engaged, a prohibited maneuver IAW the Joint-Service Technical Data (JTD) (Tab BB-27). This is approximately 50 KCAS faster and 8 degrees AOA shallower than the on speed parameters for the MA gross weight at the time of landing (Tabs J-32 and L-6). This speed forced the MP to input slight forward stick to enable touchdown resulting in the MA touching down in a three-point attitude, meaning both the main landing gear and nose landing gear impacted the ground at the same time (Tabs J-36, L-2, and V-1.7). As designed, upon initial weight on wheels (WOW) indication, the AT disengaged Speed Hold and the throttle back drive selected ground idle Engine Thrust Request (Tabs L-2 and BB-27). This three-point attitude and immediate nose gear bounce caused the nose of the aircraft to rise rapidly and excessively, which the MP attempted to stop with a forward stick input (Tabs J-36, L-2, and V-1.7).

**Figure 2**  
**MP's Landing Attitude (Tab Z-3)**
