**UNITED STATES AIR FORCE**  
**AIRCRAFT ACCIDENT INVESTIGATION**  
**BOARD REPORT**

**T-38C, 65-0337, 11 FEBRUARY 2011**

**50TH FLYING TRAINING SQUADRON  
14TH FLYING TRAINING WING  
COLUMBUS AIR FORCE BASE, MISSISSIPPI**

**LOCATION: ELLINGTON FIELD, HOUSTON, TEXAS**

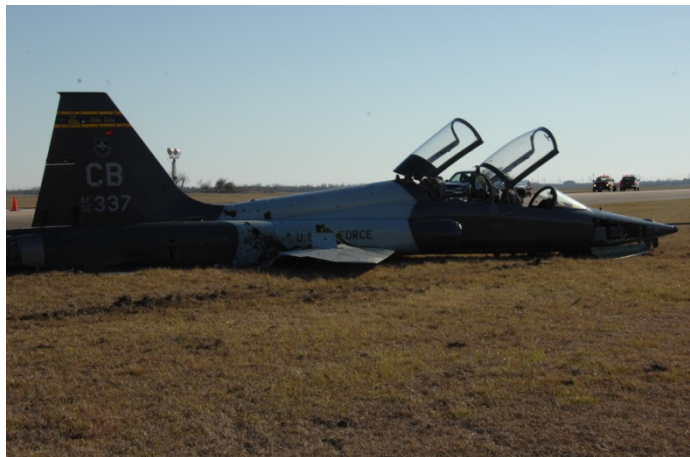
*T-38C, S/N 65-0337, 11 February 2011*

Columbus AFB, MS. (Tabs G-9, P-3, CC-15) The MP suffered minor injuries. (Tab X-4) The MA sustained damage to the landing gear, engines, right wing, and tail section. (Tab P-3 to P-5) The impact and subsequent runway departure caused minor damage to the runway and lighting system, but no damage to private property or structures. (Tabs S-15, Z-7)
