UNITED STATES AIR FORCE
AIRCRAFT ACCIDENT INVESTIGATION
BOARD REPORT

F-15D, T/N 86-0182

**493D FIGHTER SQUADRON
48TH FIGHTER WING
RAF LAKENHEATH, UNITED KINGDOM**

DATE OF ACCIDENT: 8 OCTOBER 2014

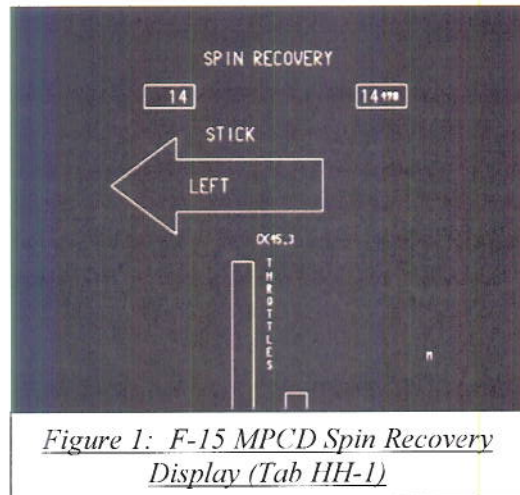
Figure 1: F-15 MPCD Spin Recovery Display (Tab HH-1)

After the MP's abrupt aft-stick pull, the MA's nose made an uncommanded slice to the left (Tab J-18, GG-1.1, HH-1). The SRD initiated 1.6 seconds later when the yaw rate exceeded 60° per second (Tab J-18, HH-1). The SRD activates when the F-15 central computer detects a spin condition (See Figure 1; Tab BB-2.2).

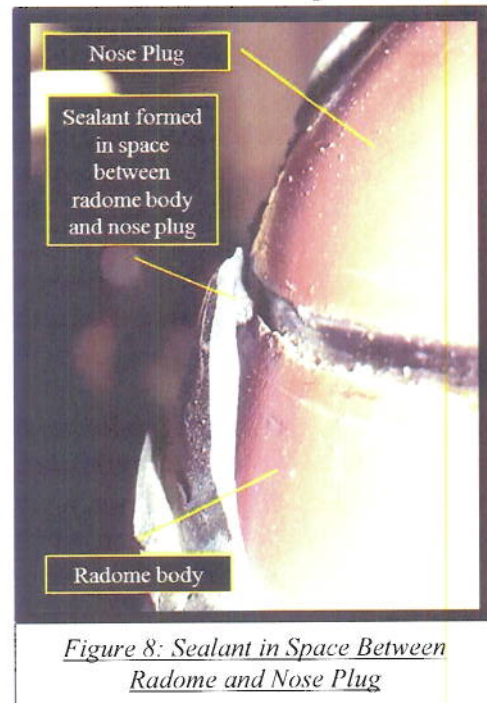
The SPO and AIB surveyed F-15 T.O.s for information on nose cap maintenance standards and concluded there are “no references in the technical data that address the amount of sealant allowed under the radome nose cap.” (Tab J-55). In other words, the guidance neither officially authorizes nor prohibits the sealant configuration found on the MA’s radome. In fact, maintenance technician testimony revealed several different techniques for removing and/or smoothing excess sealant but did not identify specific requirements (Tab V-2.7 to V-2.8, V-6.6, V-7.7). Current guidance focuses only on nose cap alignment by comparing gap measurements between the nose cap and radome body at different locations around the circumference of the assembly (Tab J-51, J-55). The MA radome passed those inspections (Tab J-55).
