**UNITED STATES AIR FORCE**  
**ABBREVIATED AIRCRAFT ACCIDENT**  
**INVESTIGATION**  
**BOARD REPORT**

**MQ-1B, T/N 08-3237**

**20TH RECONNAISSANCE SQUADRON**  
**432D WING**  
**CREECH AIR FORCE BASE, NEVADA**

**DATE OF ACCIDENT: 27 MAY 2015**

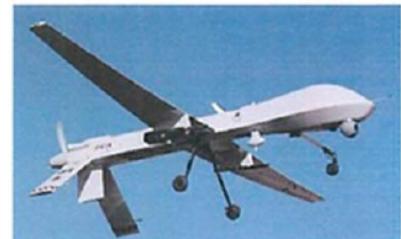
**e. MQ-1B, Predator**

The MQ-1B Predator is an armed, multi-mission, medium-altitude, long-endurance RPA employed primarily as an intelligence-collection asset and secondarily against dynamic execution targets. Given its significant loiter time, wide-range sensors, multi-mode communications suite and precision weapons, the Predator provides a unique capability to perform strike, coordination and reconnaissance missions against high-value, fleeting and time-sensitive

targets. Predators can also perform the following missions and tasks: ISR, close air support, combat search and rescue, precision strike, buddy-lase, convoy/raid overwatch, route clearance, target development and terminal air guidance. The MQ-1B's capabilities make it uniquely qualified to conduct irregular warfare operations in support of combatant commander objectives. The MQ-1B Predator system consists of an aircraft (with sensors), a ground control station, a Predator Primary Satellite Link (PPSL), and operations and maintenance personnel for deployed 24-hour operations. The basic crew for the MQ-1B Predator is one pilot and one sensor operator. The crew flies the MQ-1B Predator from inside the GCS via a line of sight (LOS) radio data link and via a satellite data link for beyond-LOS flight. A ground data terminal antenna provides LOS communications for takeoff and landing, while the PPSL provides beyond-LOS communications during the remainder of the mission (Tab CC-13 to CC-18).
