UNITED STATES AIR FORCE
AIRCRAFT ACCIDENT INVESTIGATION
BOARD REPORT

MQ-1B, T/N 01-3074

DATE OF ACCIDENT: 1 May 2011

**SUMMARY OF FACTS AND STATEMENT OF OPINION
MQ-1B, T/N 01-3074 ACCIDENT
1 MAY 2011**

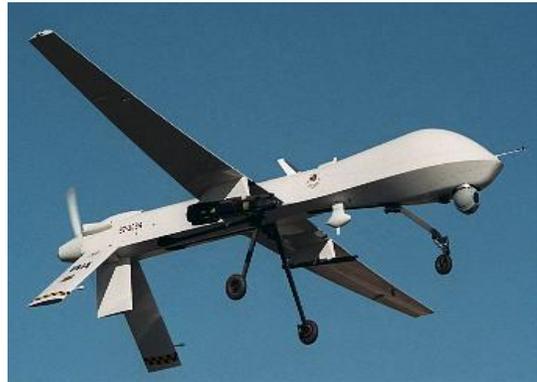
The MQ-1B Predator is a system, not just an aircraft. A fully operational system consists of four aircraft (with sensors and weapons), a ground control station (GCS), a Predator Primary Satellite Link (PPSL), and spare equipment along with operations and maintenance crews for deployed 24-hour operations (Tab CC-14). The diagram below shows the typical system components of the MQ-1B Predator.
