UNITED STATES AIR FORCE
ABBREVIATED AIRCRAFT ACCIDENT INVESTIGATION
BOARD REPORT

MQ-1B, T/N 03-3122

18TH RECONNAISSANCE SQUADRON
432D AIR EXPEDITIONARY WING
Creech Air Force Base, Nevada

DATE OF ACCIDENT: 30 January 2012

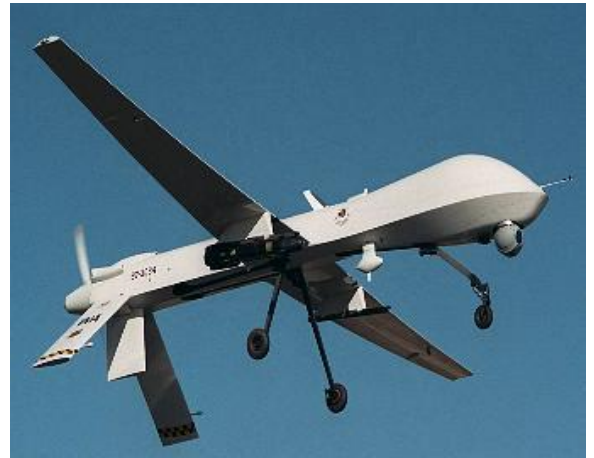
The MQ-1 Predator is an armed, multimission, medium-altitude, long endurance remotely piloted aircraft (RPA) that is employed primarily in a killer/scout role as an intelligence collection asset and secondarily against dynamic execution targets. The MQ-1's capabilities make it uniquely qualified to conduct irregular warfare operations in support of Combatant Commander objectives. (Tab CC-11).

The Predator is part of an Unmanned Aircraft System, or UAS, not just an aircraft. A fully operational UAS consists of four sensor/weapon equipped aircraft, a ground control station (GCS), a Predator Primary Satellite Link (PPSL), and spare equipment along with operations and maintenance crews for deployed 24-hour operations (Tab CC-11).
