**UNITED STATES AIR FORCE**  
**ABBREVIATED AIRCRAFT ACCIDENT INVESTIGATION**  
**BOARD REPORT**

**MQ-1B, T/N 07-3201**

**27th Special Operations Wing (AFSOC)  
Cannon AFB, New Mexico**

### ABBREVIATED AIRCRAFT ACCIDENT INVESTIGATION MQ-1B, T/N 07-3201, JALALABAD AIR BASE, AFGHANISTAN 24 JULY 2012

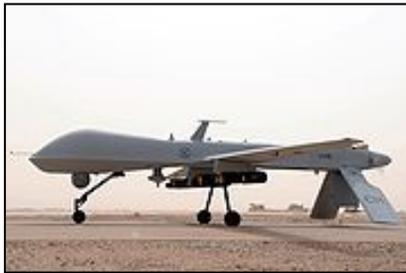
### b. MQ-1B Predator

The MQ-1B Predator aircraft is a medium-altitude, long endurance RPA. Its primary mission is conducting armed reconnaissance and interdiction against critical perishable targets. When the MQ-1B is not actively pursuing its primary mission, it augments the MQ-9 Reaper as a Joint Forces Air Component Commander-owned theater asset for reconnaissance, surveillance and target acquisition in support of the Joint Forces Commander (Tab CC-11).

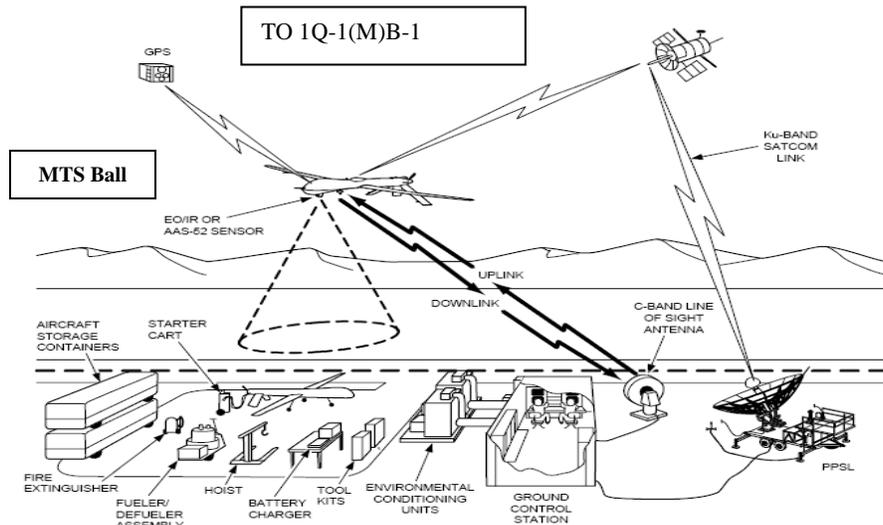
The MQ-1B Predator is a system, not just an aircraft. A fully operational system consists of four aircraft (with sensors), a ground control station (GCS), a Predator Primary Satellite Link (PPSL), along with operations and maintenance crews for a sustained 24-hour combat orbit (Tab CC-11).

The basic crew for the Predator is a pilot and sensor operator (SO). They fly the aircraft from inside the GCS via a line-of-sight (LOS) data link or a satellite (SATCOM) data link for beyond LOS flight. The aircraft is equipped with a color nose camera (generally used by the pilot for flight control), a day variable-aperture TV camera, a variable-aperture infrared (IR) camera (for
