**UNITED STATES AIR FORCE**  
**ABBREVIATED AIRCRAFT ACCIDENT INVESTIGATION**  
**BOARD REPORT**

**MQ-1B, T/N 03-3122**

**18TH RECONNAISSANCE SQUADRON**  
**432D AIR EXPEDITIONARY WING**  
**Creech Air Force Base, Nevada**

**SUBJECT: Abbreviated Accident Investigation Board Report MQ-1B, T/N 03-3122, Kandahar, Afghanistan, 30 January 2012**

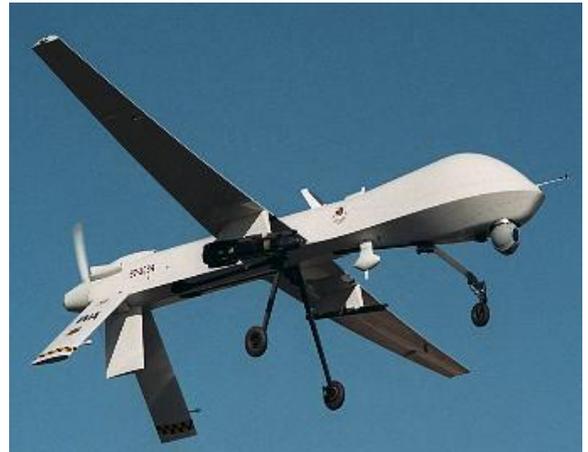
## **b. MQ-1B Predator System**

The MQ-1 Predator is an armed, multimission, medium-altitude, long endurance remotely piloted aircraft (RPA) that is employed primarily in a killer/scout role as an intelligence collection asset and secondarily against dynamic execution targets. The MQ-1's capabilities make it uniquely qualified to conduct irregular warfare operations in support of Combatant Commander objectives. (Tab CC-11).

The Predator is part of an Unmanned Aircraft System, or UAS, not just an aircraft. A fully operational UAS consists of four sensor/weapon equipped aircraft, a ground control station (GCS), a Predator Primary Satellite Link (PPSL), and spare equipment along with operations and maintenance crews for deployed 24-hour operations (Tab CC-11).
