BONE Fatigue

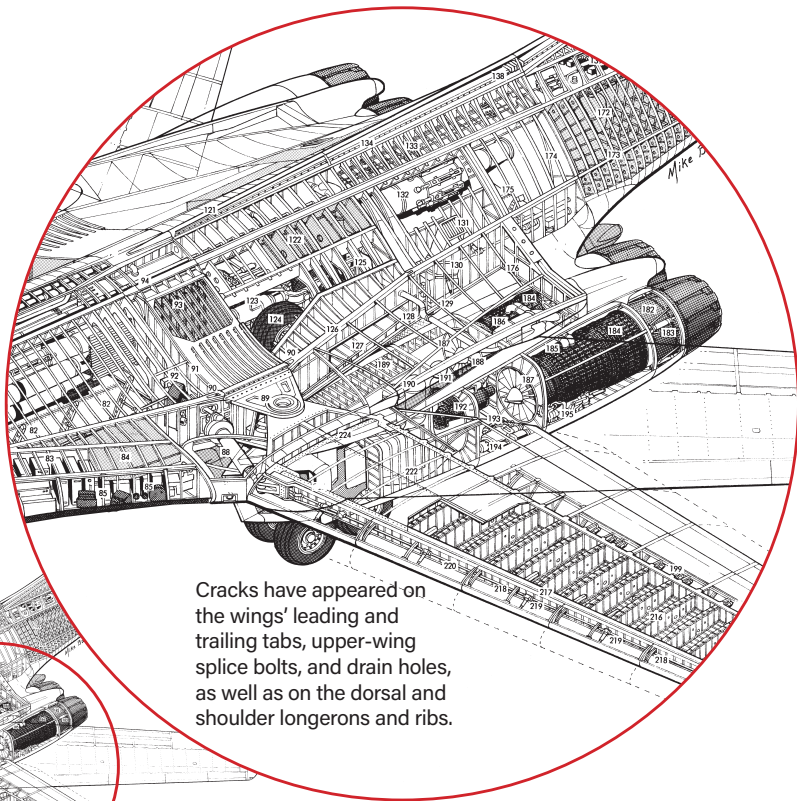
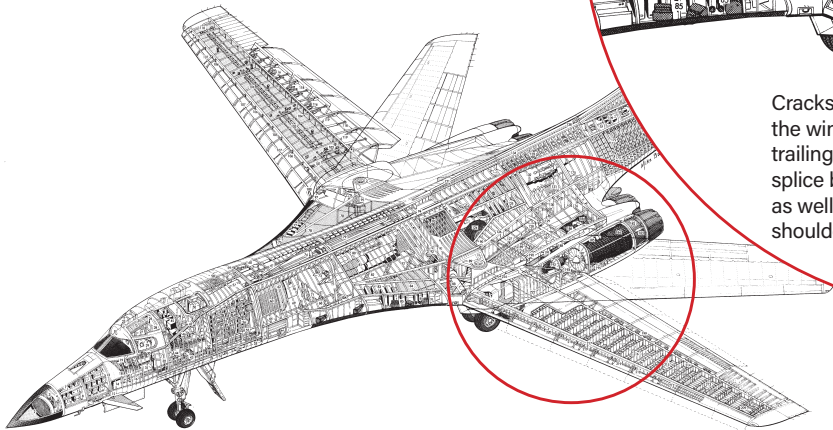
The B-1 was designed to be a penetrating bomber, flying fast and low with swept wings. In Afghanistan, however, close air support duties meant loitering at high altitudes, heavily loaded, with wings swept forward, before dashing at high-speed to respond when needed. The unanticipated stress caused cracks in highly stressed structural components joining the wings to the fuselage.
